Access Compliance Report Public Rights-of-Way (Curb Ramps)

Intersection ID: N/A	Main Street: AGNEW DR				COWGILL_LN	Location:	NE			
ADA ID: C6955997FD1C Ramp Type: Perp			Initial P	Initial Pass/Fail: Fail Overall Compliance: No				o Severity Score:	10	
Codes/Mitigation Info/Possible Solution				Field Measurements/Component Compliance						
		Possible Solutions:		Compliance Description Data Co			Comp	Compliance Description Data		
	TAR	Remove & Replace Entire Ram).	N/A	Ramp Length (in)	96.0	Yes	Ramp Slope (%)	5.9	
	1			No	Ramp Width (in)	46.5	No	Ramp XSlope (%)	2.9	
	1 A A A			N/A	Flare Type LT	N/A	N/A	Flare Type RT	N/A	
Contraction of the second	En work			N/A	Flare Slope LT (%)	N/A	N/A	Flare Slope RT (%)	N/A	
				N/A	Flare Traversable LT?	N/A	N/A	Flare Traversable RT?	N/A	
	A COMME			N/A	Landing Length (in)	N/A	N/A	DWS Provided?	N/A	
de la	N. M. S.	Surveyor Notes:		N/A	Landing Width (in)	N/A	N/A	DWS Contrast?	N/A	
		N/A		N/A	Landing Slope (%)	N/A	N/A	DWS Length (in)	N/A

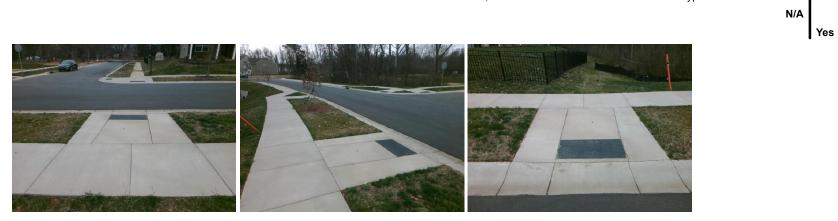
A CAR			N/A	Landing X Slope (%)	N/A	N/A	DWS Full Width?	N/A	
THE LEN ST EN	A SHE			N/A	Landing Curb? (Y/N)	N/A	N/A	DWS Offset (in)	N/A	
CONCERSE.	Viet			N/A	Shared Landing?	N/A				
		PROW/ADA:		N/A	Gutter Ponding?	N/A	N/A	Gutter Slope (%)	N/A	
1 1 Sameray	a cal	Not Found, R304.5.1, R304.5.3		N/A	Gutter Lip Ht (in)	N/A	N/A	Gutter X Slope (%)	N/A

3.47			N/A	Painted X Walk1?	No	N/A	Painted X Walk2?	N/A	
A Stable 1					X Walk 1 Direction	To W		X Walk 2 Direction	N/A	
				N/A	X Walk 1 Width (in)	N/A	N/A	X Walk 2 Width (in)	N/A	
Street 1 Name	AGNEW DR				X Walk 1 Slope (%)	2.7		X Walk 2 Slope (%)	N/A	
Stop Condition-Street 2	None				X Walk 1 X Slope (%)	2.4		X Walk 2 X Slope (%)	N/A	
Street 2 Name	N/A			N/A	Ramp inside XWalk1?	N/A	N/A	Ramp inside XWalk2?	N/A	
Stop Condition-Street 1	N/A				Road Slope (%)	N/A	N/A	Clear Space?	N/A	
					Road X Slope (%)	N/A	N/A	Clear Space to XWalk (in)	N/A	
				N/A	Any Obstructions?	N/A	N/A	Storm Grate/Utility Hazard?	N/A	
		Total Cost: \$	1850.00		Obstruction Type			Storm Grate/Utility Type		
						N/A			N/A
