Access Compliance Report

Public Rights-of-Way

(Curb Ramps)

Intersection ID: 6598	Main Street: CATHEY_RD	Cross Street: PECANWOOD_RD	Location:	N
ADA ID: C6D579D67730	Ramp Type: Perp	Initial Pass/Fail: Fail	Overall Compliance: No	Severity Score: 10

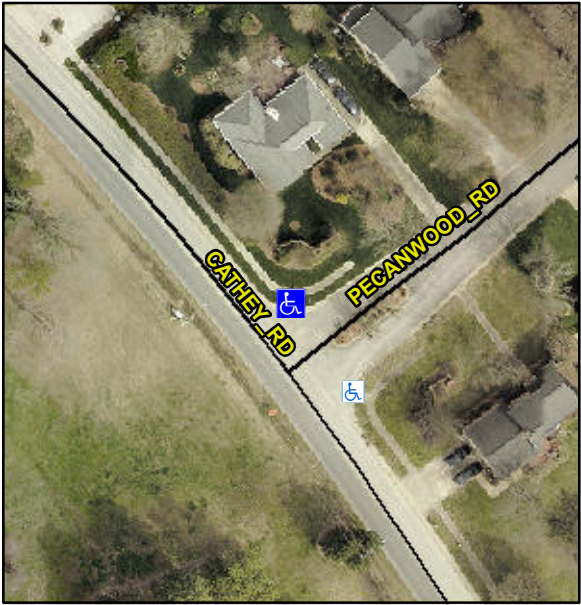
Possible Solutions:		Compliance	Description	Data
	Remove & Replace Entire Ramp.		N/A	Ramp Length (in)	78.5
			No	Ramp Width (in)	38.0
			N/A	Flare Type LT	N/A
			N/A	Flare Slope LT (%)	N/A
			N/A	Flare Traversable LT?	N/A
			N/A	Landing Length (in)	N/A
			N/A	Landing Width (in)	N/A
			N/A	Landing Slope (%)	N/A
			N/A	Landing X Slope (%)	N/A
<p>Surveyor Notes:</p> <p>N/A</p> <p>PROW/ADA:</p> <p>Not Found, R304.5.1, R304.5.3</p>			N/A	Flare Type RT	N/A
			N/A	Flare Slope RT (%)	N/A
			N/A	Flare Traversable RT?	N/A
			N/A	DWS Provided?	N/A
			N/A	DWS Contrast?	N/A
			N/A	DWS Length (in)	N/A
			N/A	DWS Full Width?	N/A
			N/A	DWS Offset (in)	N/A
			N/A	Shared Landing?	N/A
			N/A	Gutter Ponding?	N/A
			N/A	Gutter Lip Ht (in)	N/A
			N/A	Painted X Walk1?	No
				X Walk 1 Direction	To SE
			N/A	X Walk 1 Width (in)	N/A
				X Walk 1 Slope (%)	0.5

X Walk 1 X Slope (%)	1.6
			N/A	Ramp inside XWalk1?	N/A
			N/A	Road Slope (%)	N/A
			N/A	Road X Slope (%)	N/A
			N/A	Any Obstructions?	N/A
				Obstruction Type	
Total Cost:		\$ 1850.00			
			N/A		N/A
			Yes	Surface Condition? (G/P)	Good
