# Access Compliance Report

## Public Rights-of-Way

### (Curb Ramps)

| Intersection ID: 16837 | Main Street: CEDARWILD_RD | Cross Street: ELM_FOREST_DR | Location: | S |

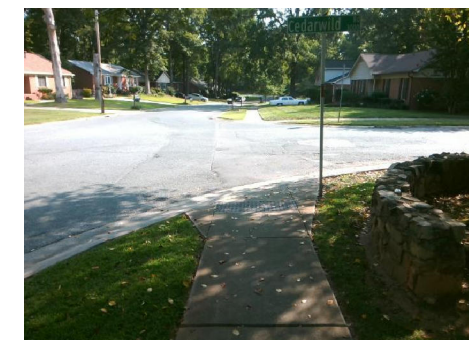
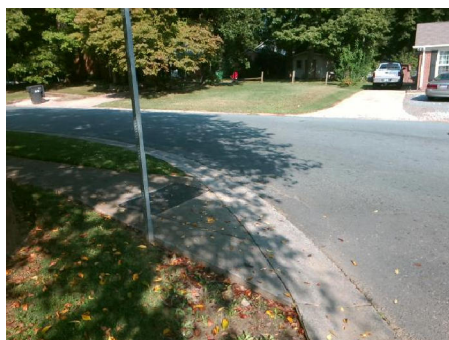
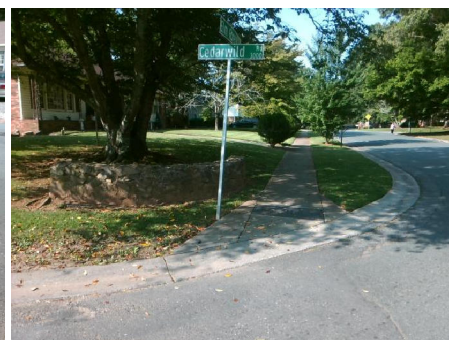
| ADA ID: C6E3984A3E15 | Ramp Type: Directional1 | Initial Pass/Fail: Fail | Overall Compliance: No | Severity Score: 10 |

**R304.5.1, R304.5.3**

| Compliance | Description | Data | Compliance | Description | Data |
|---|---|---|---|---|---|
| No | Ramp Width (in) | 47.0 | N/A | Grade Break Slope (%) | 0.0 |
| No | Ramp XSlope (%) | 4.2 | | | |

**Remove & Replace Entire Ramp.**

Total Cost: \$ 1600.00
