Access Compliance Report

Public Rights-of-Way

(Curb Ramps)

| Intersection ID: 26384 | Main Street: BEVINGTON_PL | Cross Street: ELM_LN | Location: SE |

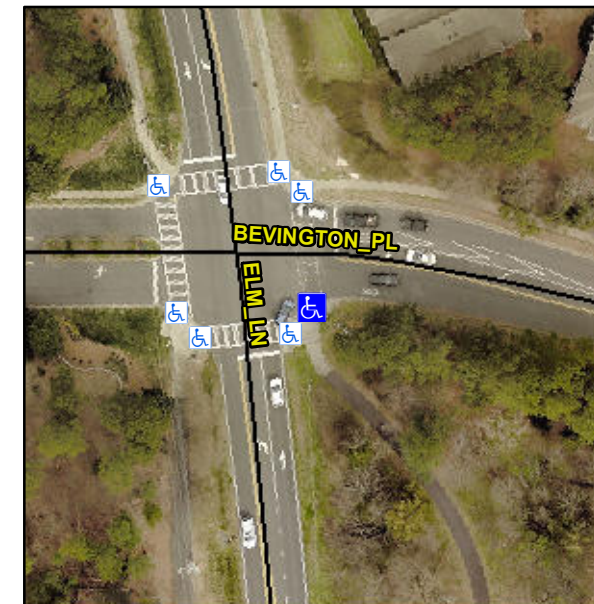
| ADA ID: C6F0DDEA82B8 | Ramp Type: Perp | Initial Pass/Fail: Fail | Overall Compliance: No |
| | | Severity Score: 27.5 | |

| Compliance | Description | Data | Compliance | Description | Data |
|---|---|---|---|---|---|
| N/A | Ramp Length (in) | 60.0 | No | Ramp Slope (%) | 9.6 |
| Yes | Ramp Width (in) | 53.0 | Yes | Ramp XSlope (%) | 0.1 |
| | | No | | Surface Condition? (G/P) | Poor |

Possible Solutions:

Remove & Replace Entire Ramp.

R304.2.2, R302.7

Total Cost: \$ 1850.00
