Access Compliance Report Public Rights-of-Way (Curb Ramps)

Intersection ID: 12820 Main Street: DEARMON DR Cross Street: DUNHILL DR Location: N **Overall Compliance: No Severity Score:** 10 **ADA ID: C6FB78AB5475** Ramp Type: BlendTrans1 Initial Pass/Fail: Fail

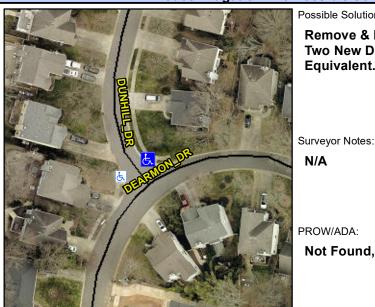
Not Found, R304.5.1, R304.5.3 N/A Gutter Lip Ht (in) 1.0 N/A Gutter X Slope (%) N/A N/A Painted X Walk1? No N/A Painted X Walk2? N/A X Walk 1 Direction To SW X Walk 2 Direction N/A N/A X Walk 1 Width (in) X Walk 2 Width (in) N/A **DUNHILL DR** X Walk 1 Slope (%) 8.5 X Walk 2 Slope (%) N/A StopSign X Walk 1 X Slope (%) 0.7 X Walk 2 X Slope (%) N/A N/A N/A N/A Ramp inside XWalk2? N/A Ramp inside XWalk1? N/A N/A Road Slope (%) 0.7 Clear Space? N/A Road X Slope (%) N/A Clear Space to XWalk (in) N/A 8.5 N/A N/A N/A Any Obstructions? Storm Grate/Utility Hazard? N/A Total Cost: **Obstruction Type** 3200.00 Storm Grate/Utility Type N/A N/A Yes Surface Condition? (G/P) Good No Curb Slope (%) 12.5

Street 1 Name Stop Condition-Street 1 Street 2 Name Stop Condition-Street 2 Possible Solutions: Remove & Replace Curb Ramp With Two New Directional Ramps or Equivalent.
