Access Compliance Report

Public Rights-of-Way

(Curb Ramps)

Intersection ID: 46915	Main Street: RAISIN_TREE_LN	Cross Street: PONDEROSA_PINE_LN	Location: E
ADA ID: C70B97937982	Ramp Type: Perp	Initial Pass/Fail: Pass	Overall Compliance: No
Severity Score: 5			
Codes/Mitigation Info/Possible Solution		Field Measurements/Component Compliance

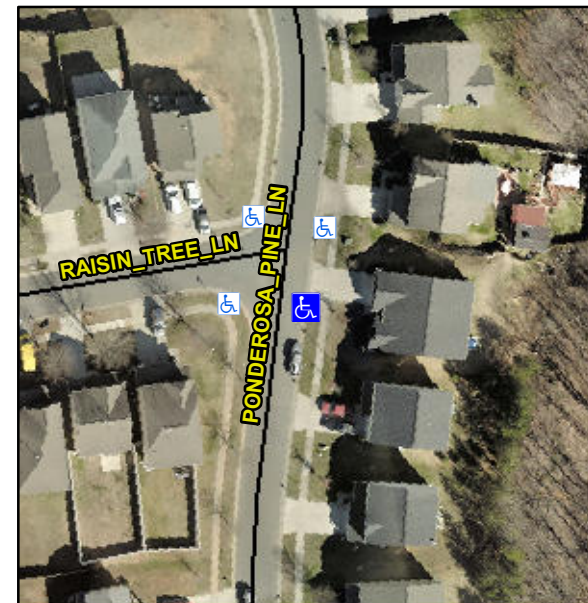
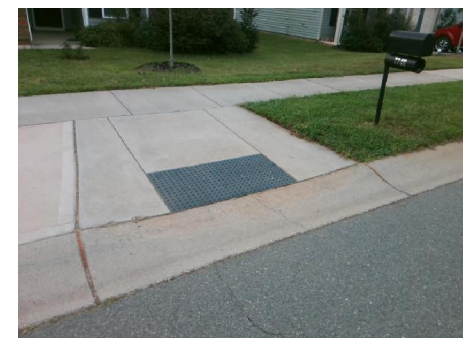
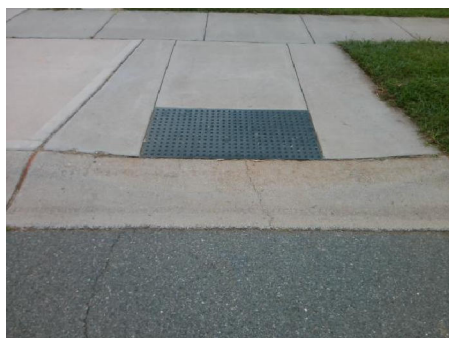
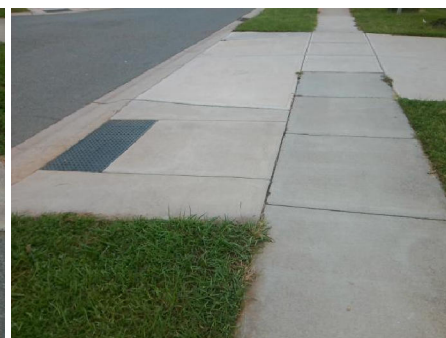
Compliance	Description	Data	Compliance	Description	Data
N/A	Ramp Length (in)	83.0	Yes	Ramp Slope (%)	7.6
Yes	Ramp Width (in)	48.0	Yes	Ramp XSlope (%)	1.3
N/A	Flare Type LT	Sloped	N/A	Flare Type RT	N/A
N/A	Flare Slope LT (%)	3.9	N/A	Flare Slope RT (%)	8.5
N/A	Flare Traversable LT?	No	N/A	Flare Traversable RT?	No
Yes	Landing Length (in)	48.0	Yes	DWS Provided?	Yes
Yes	Landing Width (in)	48.0	Yes	DWS Contrast?	Yes
No	Landing Slope (%)	2.8	Yes	DWS Length (in)	24.5
No	Landing X Slope (%)	2.1	Yes	DWS Full Width?	Yes
N/A	Landing Curb? (Y/N)	No	Yes	DWS Offset (in)	0.0
N/A	Shared Landing?	No			
Yes	Gutter Ponding?	No	No	Gutter Slope (%)	8.0
Yes	Gutter Lip Ht (in)	0.0	Yes	Gutter X Slope (%)	1.5
N/A	Painted X Walk1?	No	N/A	Painted X Walk2?	N/A
	X Walk 1 Direction	To W		X Walk 2 Direction	N/A
N/A	X Walk 1 Width (in)	N/A	N/A	X Walk 2 Width (in)	N/A
	X Walk 1 Slope (%)	4.7		X Walk 2 Slope (%)	N/A
	X Walk 1 X Slope (%)	1.9		X Walk 2 X Slope (%)	N/A

N/A	Ramp inside XWalk1?	N/A	N/A	Ramp inside XWalk2?	N/A
	Road Slope (%)	N/A	N/A	Clear Space?	Yes
	Road X Slope (%)	N/A	N/A	Clear Space to XWalk (in)	N/A
Yes	Any Obstructions?	No	Yes	Storm Grate/Utility Hazard?	No
	Obstruction Type			Storm Grate/Utility Type	
		N/A			N/A
			Yes	Surface Condition? (G/P)	Good

**Remove & Replace Entire Ramp.
Remove & Replace Gutter.**
