## **Access Compliance Report Public Rights-of-Way** (Curb Ramps)

Cross Street: N/A Intersection ID: 10029466 Main Street: KENILWORTH AV Location: NE Initial Pass/Fail: Fail **Overall Compliance: No** 12.5 ADA ID: C70F233917BC Ramp Type: Directional1 **Severity Score:**

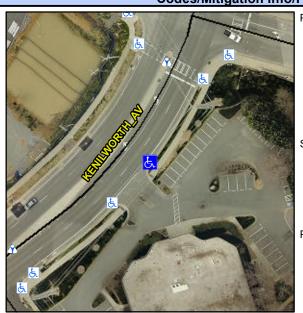
8.6

-	Possible Solutions:
-	Remove & Replace Entire Ramp.
4	
ì	
	Surveyor Notes:
	N/A
į	
The Party	
1	PROW/ADA:
-	R304.2.2
è
