# Access Compliance Report

## Public Rights-of-Way

### (Curb Ramps)

Intersection ID: 10036062	Main Street: RIVERGATE_PY	Cross Street: N/A	Location: SW
ADA ID: C71B36A10F36	Ramp Type: BlendTrans1	Initial Pass/Fail: Fail	Overall Compliance: No
		Severity Score: 10

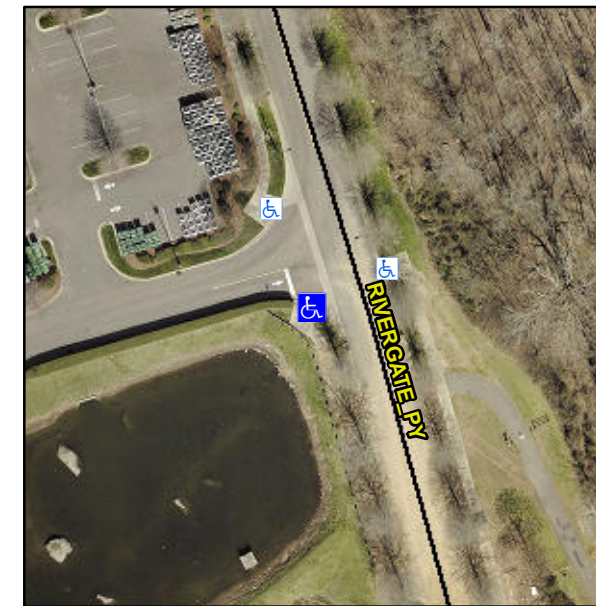
**Not Found, R304.5.1, R304.5.3**

Compliance	Description	Data	Compliance	Description	Data
N/A	Ramp Length (in)	104.0	Yes	BlendTrans Slope (%)	4.4
No	Ramp Width (in)	42.0	No	BlendTrans XSlope (%)	3.5
N/A	Flare Type LT	N/A	N/A	Flare Type RT	N/A
N/A	Flare Slope LT (%)	N/A	N/A	Flare Slope RT (%)	N/A
N/A	Flare Traversable LT?	N/A	N/A	Flare Traversable RT?	N/A
N/A	Landing Length (in)	N/A	N/A	DWS Provided?	N/A
N/A	Landing Width (in)	N/A	N/A	DWS Contrast?	N/A
N/A	Landing Slope (%)	N/A	N/A	DWS Length (in)	N/A
N/A	Landing X Slope (%)	N/A	N/A	DWS Full Width?	N/A
N/A	Landing Curb? (Y/N)	N/A	N/A	DWS Offset (in)	N/A
N/A	Shared Landing?	N/A			
N/A	Gutter Ponding?	N/A	N/A	Gutter Slope (%)	N/A
N/A	Gutter Lip Ht (in)	N/A	N/A	Gutter X Slope (%)	N/A
N/A	Painted X Walk1?	No	N/A	Painted X Walk2?	No
	X Walk 1 Direction	To NE		X Walk 2 Direction	To NW
	X Walk 1 Width (in)	N/A		X Walk 2 Width (in)	N/A
	X Walk 1 Slope (%)	4.9		X Walk 2 Slope (%)	0.3
	X Walk 1 X Slope (%)	2.3		X Walk 2 X Slope (%)	4.2

N/A	Ramp inside XWalk1?	N/A	N/A	Ramp inside XWalk2?	N/A
	Road Slope (%)	4.6		Clear Space?	N/A
	Road X Slope (%)	0.1	N/A	Clear Space to XWalk (in)	N/A
N/A	Any Obstructions?	N/A	N/A	Storm Grate/Utility Hazard?	N/A
	Obstruction Type			Storm Grate/Utility Type	
		N/A			N/A
			Yes	Surface Condition? (G/P)	Good
			No	Curb Slope (%)	23.5

**Remove & Replace Curb Ramp With Two New Directional Ramps or Equivalent.**
