# Access Compliance Report

## Public Rights-of-Way

### (Curb Ramps)

Intersection ID: 11189	Main Street: MENDHAM_DR	Cross Street: MILTON_RD	Location: NE
ADA ID: C7221CAA439D	Ramp Type: PerpDiag	Initial Pass/Fail: Fail	Overall Compliance: No
		Severity Score: 60

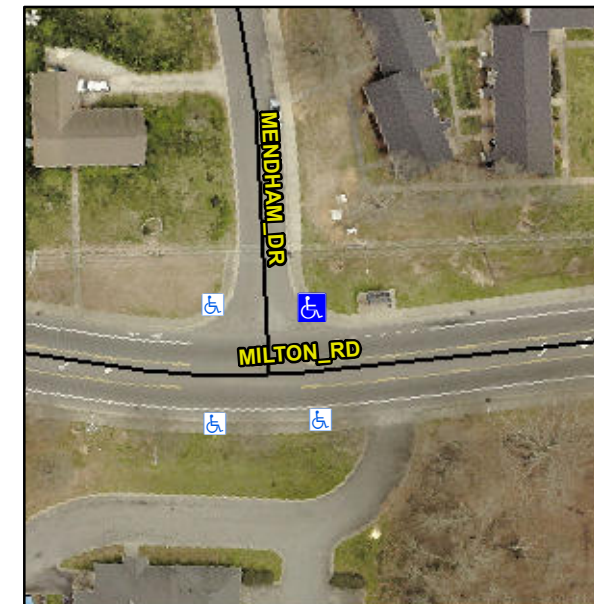
**Not Found, R304.5.1, R304.2.2**

Compliance	Description	Data	Compliance	Description	Data
N/A	Ramp Length (in)	60.0	No	Ramp Slope (%)	12.8
No	Ramp Width (in)	31.5	Yes	Ramp XSlope (%)	0.4
N/A	Flare Type LT	N/A	N/A	Flare Type RT	N/A
N/A	Flare Slope LT (%)	N/A	N/A	Flare Slope RT (%)	N/A
N/A	Flare Traversable LT?	N/A	N/A	Flare Traversable RT?	N/A
N/A	Landing Length (in)	N/A	N/A	DWS Provided?	N/A
N/A	Landing Width (in)	N/A	N/A	DWS Contrast?	N/A
N/A	Landing Slope (%)	N/A	N/A	DWS Length (in)	N/A
N/A	Landing X Slope (%)	N/A	N/A	DWS Full Width?	N/A
N/A	Landing Curb? (Y/N)	N/A	N/A	DWS Offset (in)	N/A
N/A	Shared Landing?	N/A			
N/A	Gutter Ponding?	N/A	N/A	Gutter Slope (%)	N/A
N/A	Gutter Lip Ht (in)	1.0	N/A	Gutter X Slope (%)	N/A
N/A	Painted X Walk1?	No	N/A	Painted X Walk2?	No
	X Walk 1 Direction	To W		X Walk 2 Direction	To S
N/A	X Walk 1 Width (in)	N/A	N/A	X Walk 2 Width (in)	N/A
	X Walk 1 Slope (%)	0.9		X Walk 2 Slope (%)	3.6
	X Walk 1 X Slope (%)	1.3		X Walk 2 X Slope (%)	0.0

N/A	Ramp inside XWalk1?	N/A	N/A	Ramp inside XWalk2?	N/A
	Road Slope (%)	0.8	N/A	Clear Space?	N/A
	Road X Slope (%)	1.9	N/A	Clear Space to XWalk (in)	N/A
N/A	Any Obstructions?	N/A	N/A	Storm Grate/Utility Hazard?	N/A
	Obstruction Type			Storm Grate/Utility Type	
		N/A			N/A
		Yes		Surface Condition? (G/P)	Good

**Remove & Replace Curb Ramp With Two New Directional Ramps or Equivalent.**
