Access Compliance Report

Public Rights-of-Way

(Curb Ramps)

Intersection ID: 43075	Main Street: SCOTT_AV	Cross Street: ROMANY_RD	Location: NE
ADA ID: C72827F46A1B	Ramp Type: Perp	Initial Pass/Fail: Fail	Overall Compliance: No
Codes/Mitigation Info/Possible Solution			Severity Score: 46.25
			Field Measurements/Component Compliance

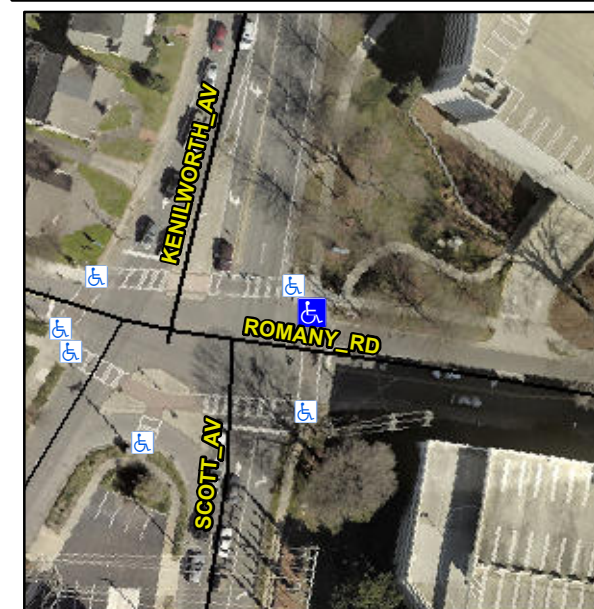
Not Found, R304.5.1, R304.2.2, R304.5.3

Compliance	Description	Data	Compliance	Description	Data
N/A	Ramp Length (in)	102.0	No	Ramp Slope (%)	12.2
No	Ramp Width (in)	47.5	No	Ramp XSlope (%)	6.8
N/A	Flare Type LT	N/A	N/A	Flare Type RT	N/A
N/A	Flare Slope LT (%)	N/A	N/A	Flare Slope RT (%)	N/A
N/A	Flare Traversable LT?	N/A	N/A	Flare Traversable RT?	N/A
N/A	Landing Length (in)	N/A	N/A	DWS Provided?	N/A
N/A	Landing Width (in)	N/A	N/A	DWS Contrast?	N/A
N/A	Landing Slope (%)	N/A	N/A	DWS Length (in)	N/A
N/A	Landing X Slope (%)	N/A	N/A	DWS Full Width?	N/A
N/A	Landing Curb? (Y/N)	N/A	N/A	DWS Offset (in)	N/A
N/A	Shared Landing?	N/A			
N/A	Gutter Ponding?	N/A	N/A	Gutter Slope (%)	N/A
N/A	Gutter Lip Ht (in)	N/A	N/A	Gutter X Slope (%)	N/A
N/A	Painted X Walk1?	Yes	N/A	Painted X Walk2?	N/A
	X Walk 1 Direction	To S		X Walk 2 Direction	N/A
N/A	X Walk 1 Width (in)	104.0	N/A	X Walk 2 Width (in)	N/A
	X Walk 1 Slope (%)	7.7		X Walk 2 Slope (%)	N/A
	X Walk 1 X Slope (%)	1.8		X Walk 2 X Slope (%)	N/A

N/A	Ramp inside XWalk1?	Yes	N/A	Ramp inside XWalk2?	N/A
	Road Slope (%)	N/A	N/A	Clear Space?	N/A
	Road X Slope (%)	N/A	N/A	Clear Space to XWalk (in)	N/A
N/A	Any Obstructions?	N/A	N/A	Storm Grate/Utility Hazard?	N/A
	Obstruction Type			Storm Grate/Utility Type	
		N/A			N/A
			Yes	Surface Condition? (G/P)	Good

Possible Solutions:

Remove & Replace Entire Ramp.
