Access Compliance Report

Public Rights-of-Way

(Curb Ramps)

Intersection ID: 2507	Main Street: CAMBRIDGE_BAY_DR	Cross Street: SNOW_HILL_CT	Location: S
ADA ID: C7356D929385	Ramp Type: PerpDiag	Initial Pass/Fail: Fail	Overall Compliance: No
Severity Score: 26.25			
Codes/Mitigation Info/Possible Solution		Field Measurements/Component Compliance

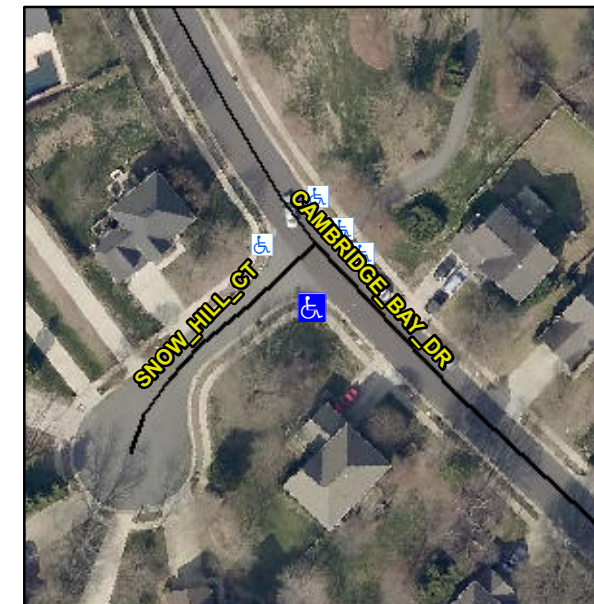
Not Found, R304.2.2, R304.5.3

Compliance	Description	Data	Compliance	Description	Data
N/A	Ramp Length (in)	47.0	No	Ramp Slope (%)	12.5
Yes	Ramp Width (in)	48.0	No	Ramp XSlope (%)	2.4
N/A	Flare Type LT	N/A	N/A	Flare Type RT	N/A
N/A	Flare Slope LT (%)	N/A	N/A	Flare Slope RT (%)	N/A
N/A	Flare Traversable LT?	N/A	N/A	Flare Traversable RT?	N/A
N/A	Landing Length (in)	N/A	N/A	DWS Provided?	N/A
N/A	Landing Width (in)	N/A	N/A	DWS Contrast?	N/A
N/A	Landing Slope (%)	N/A	N/A	DWS Length (in)	N/A
N/A	Landing X Slope (%)	N/A	N/A	DWS Full Width?	N/A
N/A	Landing Curb? (Y/N)	N/A	N/A	DWS Offset (in)	N/A
N/A	Shared Landing?	N/A			
N/A	Gutter Ponding?	N/A	N/A	Gutter Slope (%)	N/A
N/A	Gutter Lip Ht (in)	N/A	N/A	Gutter X Slope (%)	N/A
N/A	Painted X Walk1?	No	N/A	Painted X Walk2?	No
	X Walk 1 Direction	To NE		X Walk 2 Direction	To NW
N/A	X Walk 1 Width (in)	N/A	N/A	X Walk 2 Width (in)	N/A
	X Walk 1 Slope (%)	4.4		X Walk 2 Slope (%)	4.2
	X Walk 1 X Slope (%)	4.5		X Walk 2 X Slope (%)	1.8

N/A	Ramp inside XWalk1?	N/A	N/A	Ramp inside XWalk2?	N/A
	Road Slope (%)	2.0	N/A	Clear Space?	N/A
	Road X Slope (%)	8.6	N/A	Clear Space to XWalk (in)	N/A
N/A	Any Obstructions?	N/A	N/A	Storm Grate/Utility Hazard?	N/A
	Obstruction Type			Storm Grate/Utility Type	
		N/A			N/A
			Yes	Surface Condition? (G/P)	Good

Remove & Replace Curb Ramp With Two New Directional Ramps or Equivalent.
