# Access Compliance Report

## Public Rights-of-Way

### (Curb Ramps)

| Intersection ID: 27452 | Main Street: BALLANTYNE COMMONS PY | Cross Street: BALLANTYNE CORPORATE PL | Location: NE |

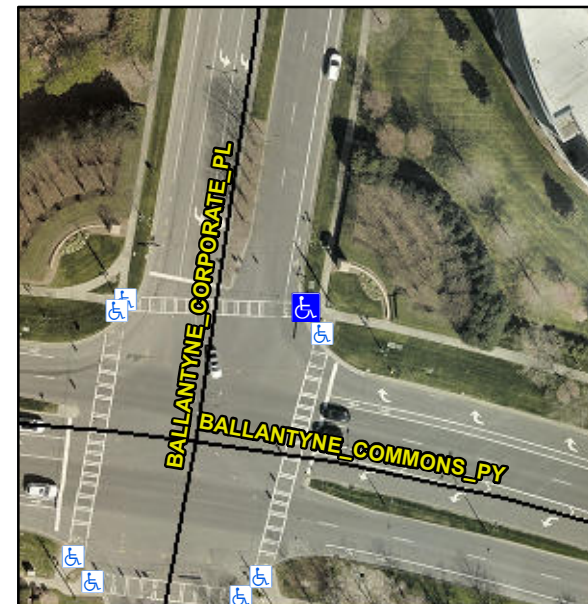
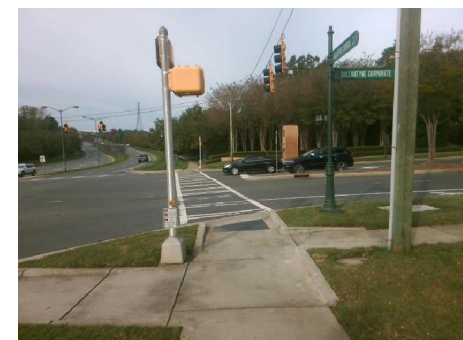
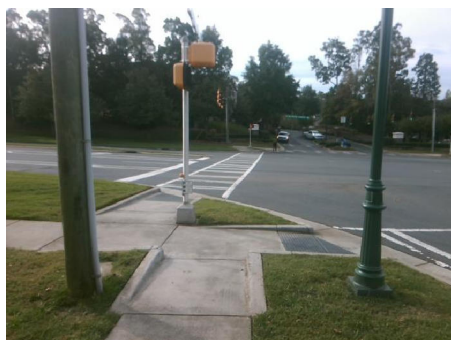
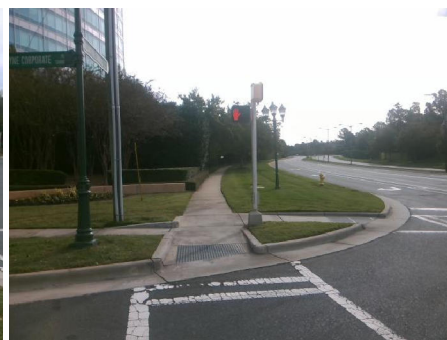
| Severity Score: 2.75 | | | |

**R304.2.2-Perp, R304.3.2-Para, R305.1.4**

| Compliance | Description | Data | Compliance | Description | Data |
|---|---|---|---|---|---|
| No | Landing Slope (%) | 3.8 | Yes | DWS Length (in) | 25.5 |
| Yes | Landing X Slope (%) | 1.3 | No | DWS Full Width? | No |

**Remove & Replace Entire Ramp.**

Total Cost: \$ 1600.00
