# Access Compliance Report

## Public Rights-of-Way

### (Curb Ramps)

Intersection ID: 24077	Main Street: LANDSBURG_LN	Cross Street: OLDENBURG_DR	Location: E
ADA ID: C742A514381F	Ramp Type: PerpDiag	Initial Pass/Fail: Fail	Overall Compliance: No
Severity Score: 37.5			
Codes/Mitigation Info/Possible Solution		Field Measurements/Component Compliance

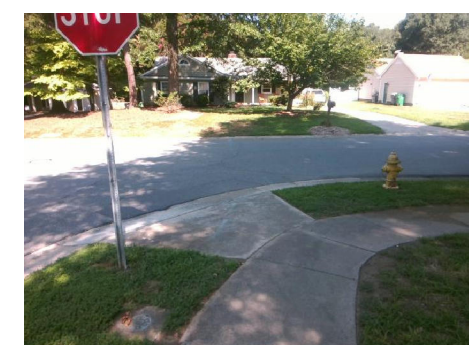
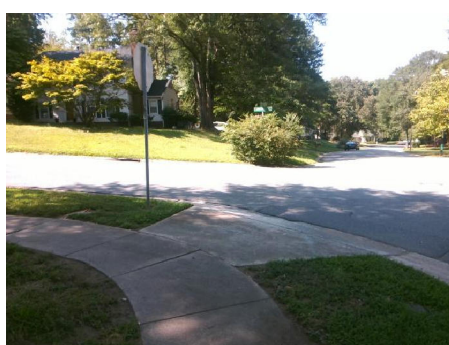
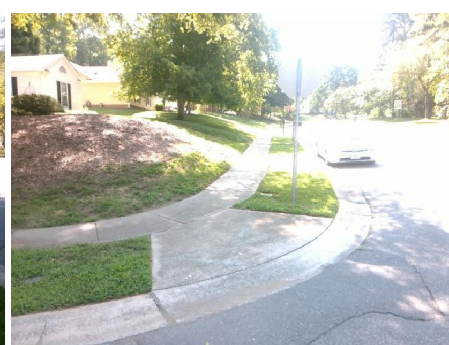
Compliance	Description	Data	Compliance	Description	Data
N/A	Ramp Length (in)	74.0	No	Ramp Slope (%)	10.4
Yes	Ramp Width (in)	71.0	No	Ramp XSlope (%)	7.9
N/A	Flare Type LT	N/A	N/A	Flare Type RT	N/A
N/A	Flare Slope LT (%)	N/A	N/A	Flare Slope RT (%)	N/A
N/A	Flare Traversable LT?	N/A	N/A	Flare Traversable RT?	N/A
N/A	Landing Length (in)	N/A	N/A	DWS Provided?	N/A
N/A	Landing Width (in)	N/A	N/A	DWS Contrast?	N/A
N/A	Landing Slope (%)	N/A	N/A	DWS Length (in)	N/A
N/A	Landing X Slope (%)	N/A	N/A	DWS Full Width?	N/A
N/A	Landing Curb? (Y/N)	N/A	N/A	DWS Offset (in)	N/A
N/A	Shared Landing?	N/A			
N/A	Gutter Ponding?	N/A	N/A	Gutter Slope (%)	N/A
N/A	Gutter Lip Ht (in)	N/A	N/A	Gutter X Slope (%)	N/A
N/A	Painted X Walk1?	No	N/A	Painted X Walk2?	No
	X Walk 1 Direction	To NW		X Walk 2 Direction	To SW
N/A	X Walk 1 Width (in)	N/A	N/A	X Walk 2 Width (in)	N/A
	X Walk 1 Slope (%)	3.4		X Walk 2 Slope (%)	1.8
	X Walk 1 X Slope (%)	1.2		X Walk 2 X Slope (%)	3.2

N/A	Ramp inside XWalk1?	N/A	N/A	Ramp inside XWalk2?	N/A
	Road Slope (%)	2.1	N/A	Clear Space?	N/A
	Road X Slope (%)	0.4	N/A	Clear Space to XWalk (in)	N/A
N/A	Any Obstructions?	N/A	N/A	Storm Grate/Utility Hazard?	N/A
	Obstruction Type			Storm Grate/Utility Type	
		N/A			N/A
		Yes		Surface Condition? (G/P)	Good

**Remove & Replace Curb Ramp With Two New Directional Ramps or Equivalent.**

**Not Found, R304.2.2, R304.5.3**
