Access Compliance Report

Public Rights-of-Way

(Curb Ramps)

| Intersection ID: 10402 | Main Street: BURTON_ST | Cross Street: HAMILTON_ST | Location: E |

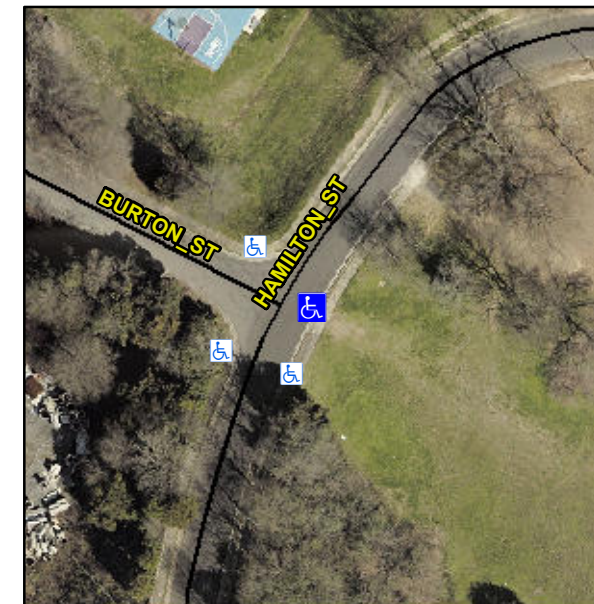
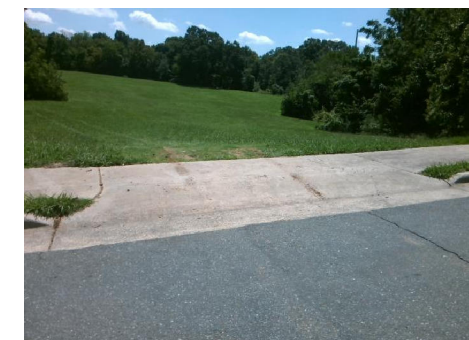
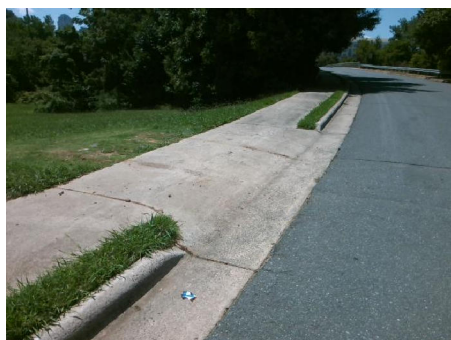
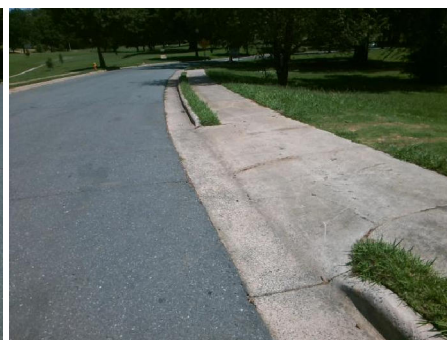
| ADA ID: C747730C7306 | Ramp Type: Perp | Initial Pass/Fail: Fail | Overall Compliance: No |
| Severity Score: 13.75 | | | |

Not Found, R304.2.2, R304.5.3

| Compliance | Description | Data | Compliance | Description | Data |
|---|---|---|---|---|---|
| N/A | Ramp Length (in) | 55.0 | No | Ramp Slope (%) | 11.7 |
| Yes | Ramp Width (in) | 105.0 | No | Ramp XSlope (%) | 3.7 |

Remove & Replace Entire Ramp.
