Access Compliance Report

Public Rights-of-Way

(Curb Ramps)

| Intersection ID: 23642 | Main Street: CASTLEGATE_DR | Cross Street: HEATHERFORD_DR | Location: NW |

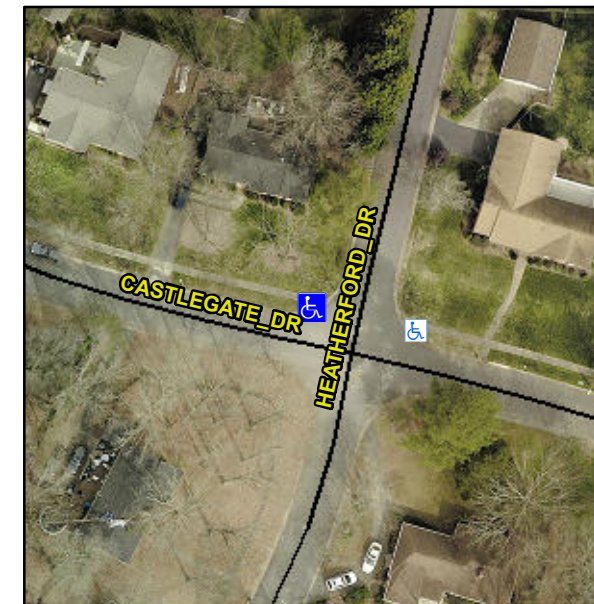
| ADA ID: C75407B2E46E | Ramp Type: Directional1 | Initial Pass/Fail: Fail | Overall Compliance: No |
| Severity Score: 10 | | | |

| Compliance | Description | Data | Compliance | Description | Data |
|---|---|---|---|---|---|
| No | Ramp Width (in) | 47.0 | N/A | Grade Break Slope (%) | 0.0 |
| No | Ramp XSlope (%) | 2.2 | | | |

Remove & Replace Entire Ramp.

R304.5.1, R304.5.3

Total Cost: \$ 1600.00
