# Access Compliance Report

## Public Rights-of-Way

### (Curb Ramps)

Intersection ID: 20132	Main Street: SARDIS_RD	Cross Street: WINGRAVE_DR	Location: SW
ADA ID: C758FBD35515	Ramp Type: PerpDiag	Initial Pass/Fail: Fail	Overall Compliance: No
Severity Score: 22.5			
Codes/Mitigation Info/Possible Solution		Field Measurements/Component Compliance

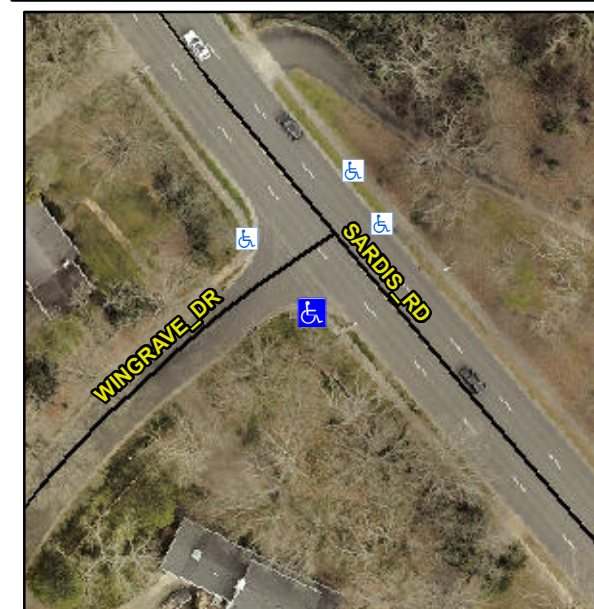
**Not Found, R304.5.1, R304.2.2, R304.5.3**

Compliance	Description	Data	Compliance	Description	Data
N/A	Ramp Length (in)	63.0	No	Ramp Slope (%)	8.9
No	Ramp Width (in)	38.0	No	Ramp XSlope (%)	3.7
N/A	Flare Type LT	N/A	N/A	Flare Type RT	N/A
N/A	Flare Slope LT (%)	N/A	N/A	Flare Slope RT (%)	N/A
N/A	Flare Traversable LT?	N/A	N/A	Flare Traversable RT?	N/A
N/A	Landing Length (in)	N/A	N/A	DWS Provided?	N/A
N/A	Landing Width (in)	N/A	N/A	DWS Contrast?	N/A
N/A	Landing Slope (%)	N/A	N/A	DWS Length (in)	N/A
N/A	Landing X Slope (%)	N/A	N/A	DWS Full Width?	N/A
N/A	Landing Curb? (Y/N)	N/A	N/A	DWS Offset (in)	N/A
N/A	Shared Landing?	N/A			
N/A	Gutter Ponding?	N/A	N/A	Gutter Slope (%)	N/A
N/A	Gutter Lip Ht (in)	N/A	N/A	Gutter X Slope (%)	N/A
N/A	Painted X Walk1?	No	N/A	Painted X Walk2?	No
	X Walk 1 Direction	To NE		X Walk 2 Direction	To NW
N/A	X Walk 1 Width (in)	N/A	N/A	X Walk 2 Width (in)	N/A
	X Walk 1 Slope (%)	1.9		X Walk 2 Slope (%)	0.5
	X Walk 1 X Slope (%)	1.1		X Walk 2 X Slope (%)	2.8

N/A	Ramp inside XWalk1?	N/A	N/A	Ramp inside XWalk2?	N/A
	Road Slope (%)	3.3	N/A	Clear Space?	N/A
	Road X Slope (%)	0.8	N/A	Clear Space to XWalk (in)	N/A
N/A	Any Obstructions?	N/A	N/A	Storm Grate/Utility Hazard?	N/A
	Obstruction Type			Storm Grate/Utility Type	
		N/A			N/A
			Yes	Surface Condition? (G/P)	Good

**Remove & Replace Curb Ramp With Two New Directional Ramps or Equivalent.**
