Access Compliance Report

Public Rights-of-Way

(Curb Ramps)

Intersection ID: 52521	Main Street: LORNA_ST	Cross Street: MCCLINTOCK_RD	Location: E
ADA ID: C75E43EA509F	Ramp Type: Perp	Initial Pass/Fail: Fail	Overall Compliance: No
Severity Score: 8.75			
Codes/Mitigation Info/Possible Solution		Field Measurements/Component Compliance

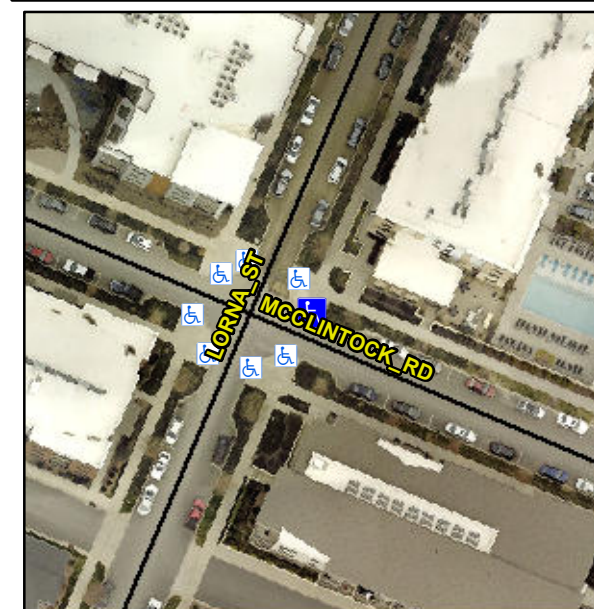
Compliance	Description	Data	Compliance	Description	Data
N/A	Ramp Length (in)	77.5	Yes	Ramp Slope (%)	6.4
No	Ramp Width (in)	47.0	Yes	Ramp XSlope (%)	1.5
N/A	Flare Type LT	N/A	N/A	Flare Type RT	N/A
N/A	Flare Slope LT (%)	N/A	N/A	Flare Slope RT (%)	N/A
N/A	Flare Traversable LT?	N/A	N/A	Flare Traversable RT?	N/A
N/A	Landing Length (in)	N/A	N/A	DWS Provided?	N/A
N/A	Landing Width (in)	N/A	N/A	DWS Contrast?	N/A
N/A	Landing Slope (%)	N/A	N/A	DWS Length (in)	N/A
N/A	Landing X Slope (%)	N/A	N/A	DWS Full Width?	N/A
N/A	Landing Curb? (Y/N)	N/A	N/A	DWS Offset (in)	N/A
N/A	Shared Landing?	N/A			
N/A	Gutter Ponding?	N/A	N/A	Gutter Slope (%)	N/A
N/A	Gutter Lip Ht (in)	N/A	N/A	Gutter X Slope (%)	N/A
N/A	Painted X Walk1?	No	N/A	Painted X Walk2?	N/A
	X Walk 1 Direction	To SW		X Walk 2 Direction	N/A
N/A	X Walk 1 Width (in)	N/A	N/A	X Walk 2 Width (in)	N/A
	X Walk 1 Slope (%)	6.7		X Walk 2 Slope (%)	N/A
	X Walk 1 X Slope (%)	2.1		X Walk 2 X Slope (%)	N/A

N/A	Ramp inside XWalk1?	N/A	N/A	Ramp inside XWalk2?	N/A
	Road Slope (%)	N/A	N/A	Clear Space?	N/A
	Road X Slope (%)	N/A	N/A	Clear Space to XWalk (in)	N/A
N/A	Any Obstructions?	N/A	N/A	Storm Grate/Utility Hazard?	N/A
	Obstruction Type			Storm Grate/Utility Type	
		N/A			N/A
			Yes	Surface Condition? (G/P)	Good

Remove & Replace Entire Ramp.

R304.5.1
