Access Compliance Report Public Rights-of-Way (Curb Ramps)

Intersection ID: 14806 Main Street: HENLEY PL **Cross Street: QUEENS RD** Location: NW Initial Pass/Fail: Fail **Overall Compliance: No Severity Score: ADA ID: C75FDFF87095** Ramp Type: Directional1 37.5

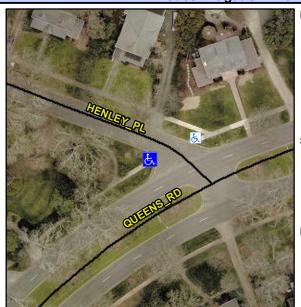
HENLEY PL Street 1 Name Stop Condition-Street 1 StopSign N/A Street 2 Name Stop Condition-Street 2 N/A Possible Solutions: Compliance Description N/A Remove & Replace Entire Ramp. Yes No No N/A N/A Surveyor Notes: N/A N/A **NO CURB LINE** N/A N/A N/A PROW/ADA: N/A R304.2.2, R304.5.3 N/A N/A N/A N/A
