Access Compliance Report

Public Rights-of-Way

(Curb Ramps)

Intersection ID: 11511	Main Street: E_18TH_ST	Cross Street: N_DAVIDSON_ST	Location: S
ADA ID: C768F8FCB1B5	Ramp Type: PerpDiag	Initial Pass/Fail: Fail	Overall Compliance: No
Severity Score: 13.75			
Codes/Mitigation Info/Possible Solution		Field Measurements/Component Compliance

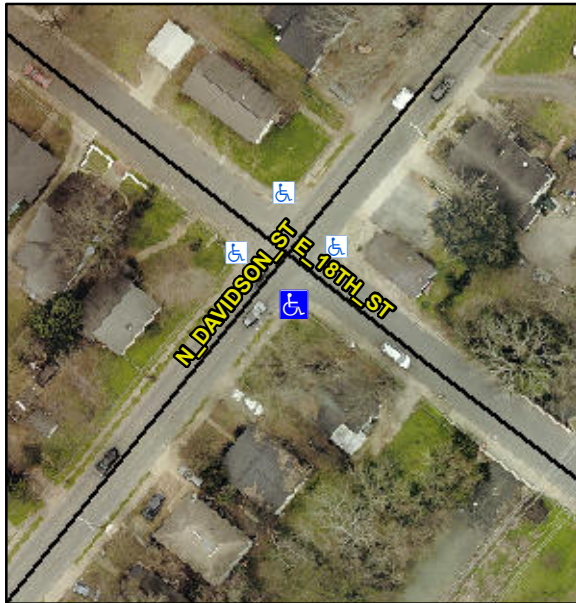
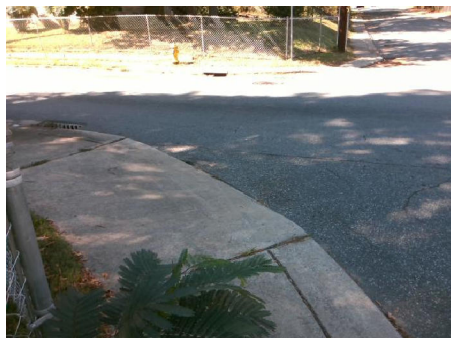
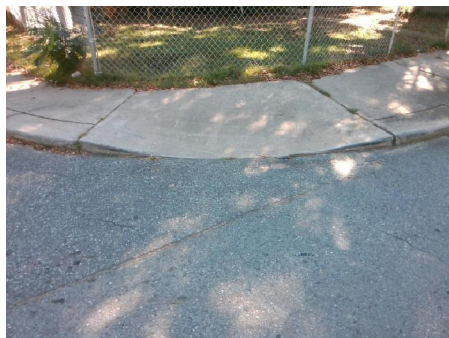
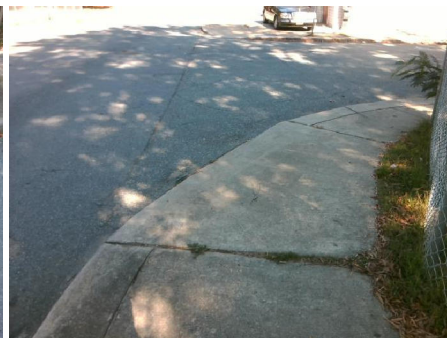
Not Found, R304.2.2, R304.5.3

Compliance	Description	Data	Compliance	Description	Data
N/A	Ramp Length (in)	70.0	No	Ramp Slope (%)	10.6
Yes	Ramp Width (in)	50.0	No	Ramp XSlope (%)	3.9
N/A	Flare Type LT	N/A	N/A	Flare Type RT	N/A
N/A	Flare Slope LT (%)	N/A	N/A	Flare Slope RT (%)	N/A
N/A	Flare Traversable LT?	N/A	N/A	Flare Traversable RT?	N/A
N/A	Landing Length (in)	N/A	N/A	DWS Provided?	N/A
N/A	Landing Width (in)	N/A	N/A	DWS Contrast?	N/A
N/A	Landing Slope (%)	N/A	N/A	DWS Length (in)	N/A
N/A	Landing X Slope (%)	N/A	N/A	DWS Full Width?	N/A
N/A	Landing Curb? (Y/N)	N/A	N/A	DWS Offset (in)	N/A
N/A	Shared Landing?	N/A			
N/A	Gutter Ponding?	N/A	N/A	Gutter Slope (%)	N/A
N/A	Gutter Lip Ht (in)	N/A	N/A	Gutter X Slope (%)	N/A
N/A	Painted X Walk1?	No	N/A	Painted X Walk2?	No
	X Walk 1 Direction	To NE		X Walk 2 Direction	To NW
N/A	X Walk 1 Width (in)	N/A	N/A	X Walk 2 Width (in)	N/A
	X Walk 1 Slope (%)	2.0		X Walk 2 Slope (%)	6.3
	X Walk 1 X Slope (%)	6.5		X Walk 2 X Slope (%)	0.1

N/A	Ramp inside XWalk1?	N/A	N/A	Ramp inside XWalk2?	N/A
	Road Slope (%)	3.2	N/A	Clear Space?	N/A
	Road X Slope (%)	3.4	N/A	Clear Space to XWalk (in)	N/A
N/A	Any Obstructions?	N/A	N/A	Storm Grate/Utility Hazard?	N/A
	Obstruction Type			Storm Grate/Utility Type	
		N/A			N/A
		Yes		Surface Condition? (G/P)	Good

Remove & Replace Curb Ramp With Two New Directional Ramps or Equivalent.
