## Access Compliance Report Public Rights-of-Way (Curb Ramps)

Intersection ID: 10017106Main Street: CENTRAL\_AVCross Street: N/ALocation:NEADA ID: C77A782D6755Ramp Type: ParaDiagInitial Pass/Fail: FailOverall Compliance: NoSeverity Score: 13.75

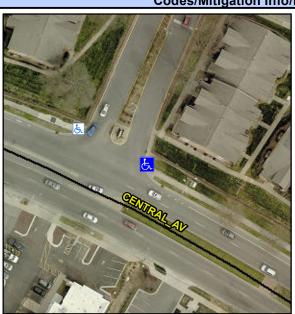
R304.3.2, R304.5.3

Compliance Description Data		Comp	oliance Description	Data	
N/A	Ramp Length LT (in)	57.0	N/A	Ramp Length RT (in)	53.0
Yes	Ramp Width LT (in)	72.0	Yes	Ramp Width RT (in)	83.0
Yes	Ramp Slope LT (%)	5.3	No	Ramp Slope RT (%)	9.6
Yes	Ramp XSlope LT (%)	1.4	No	Ramp XSlope RT (%)	2.4
N/A	Landing Length (in)	N/A	N/A	DWS Provided?	N/A
N/A	Landing Width (in)	N/A	N/A	DWS Contrast?	N/A
N/A	Landing Slope (%)	N/A	N/A	DWS Length (in)	N/A
N/A	Landing X Slope (%)	N/A	N/A	DWS Full Width?	N/A
N/A	Landing Curb? (Y/N)	N/A	N/A	DWS Offset (in)	N/A
N/A	Shared Landing?	N/A			
N/A	Gutter Ponding?	N/A	N/A	Gutter Slope (%)	N/A
N/A	Gutter Lip Ht (in)	N/A	N/A	Gutter X Slope (%)	N/A
N/A	Painted X Walk1?	No	N/A	Painted X Walk2?	No
	X Walk 1 Direction	To NW		X Walk 2 Direction	To SW
N/A	X Walk 1 Width (in)	N/A	N/A	X Walk 2 Width (in)	N/A
	X Walk 1 Slope (%)	2.7		X Walk 2 Slope (%)	0.3
	X Walk 1 X Slope (%)	1.0		X Walk 2 X Slope (%)	0.1
N/A	Ramp inside XWalk1?	N/A	N/A	Ramp inside XWalk2?	N/A

Road Slope (%)	1.8	N/A	Clear Space?	N/A
	Road X Slope (%)	0.3	N/A	Clear Space to XWalk (in)	N/A
N/A	Any Obstructions?	N/A	N/A	Storm Grate/Utility Hazard?	N/A
	Obstruction Type			Storm Grate/Utility Type	
		N/A			N/A
			Yes	Surface Condition? (G/P)	Good
			N/A	Curb Slope (%)	11.0

Remove & Replace Curb Ramp With Two New Directional Ramps or Equivalent.

Total Cost: \$ 3200.00
