Access Compliance Report

Public Rights-of-Way

(Curb Ramps)

Intersection ID: 51615	Main Street: BENFIELD_RD	Cross Street: PROSPERITY_CHURCH_RD	Location: SW
ADA ID: C77CB1B1E4F7	Ramp Type: Directional1	Initial Pass/Fail: Pass	Overall Compliance: No
		Severity Score: 0.25

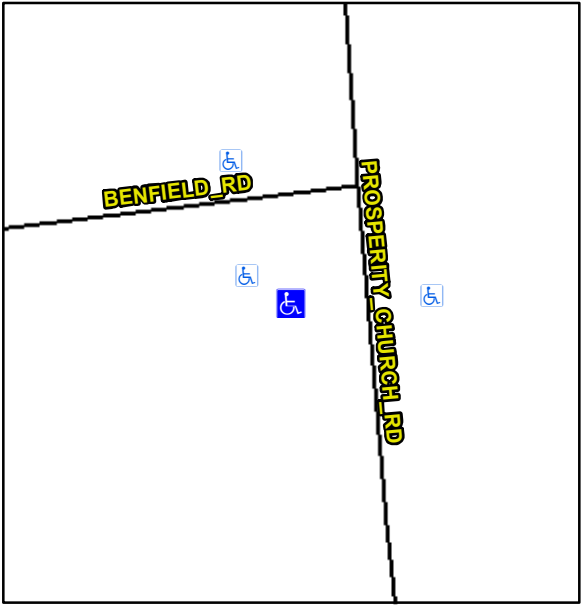
Possible Solutions:	Compliance	Description	Data	Compliance
	Remove & Replace Entire Ramp.	N/A	Ramp Length (in)	113.0	N/A
		Yes	Ramp Width (in)	68.0	N/A
<p>Surveyor Notes:</p> <p>N/A</p>		Yes	Ramp Slope (%)	2.6	N/A
		Yes	Ramp XSlope (%)	3.3	
		Yes	Flare Type LT	N/A	Yes
<p>PROW/ADA:</p> <p>Not Found, R304.2.2-Perp, R304.3.2-Para, R305.2</p>		N/A	Flare Slope LT (%)	N/A	N/A
		N/A	Flare Traversable LT?	No	N/A
		Yes	Landing Length (in)	48.0	Yes
<p>Total Cost:</p> <p>\$ 1600.00</p>		Yes	Landing Width (in)	72.0	Yes
		No	Landing Slope (%)	4.7	Yes
		Yes	Landing X Slope (%)	1.2	Yes
<p>Street 1 Name</p> <p>PROSPERITY CHURCH RD</p>		N/A	Landing Curb? (Y/N)	No	Yes
		N/A	Shared Landing?	No	No
		Yes	Gutter Ponding?	No	Yes
<p>Stop Condition-Street 1</p> <p>Signal</p>		Yes	Gutter Lip Ht (in)	0.0	Yes
		N/A	Painted X Walk1?	Yes	
		N/A	X Walk 1 Direction	To E

<p>Street 2 Name</p> <p>N/A</p>		Yes	X Walk 1 Width (in)	106.0	
		Yes	X Walk 1 Slope (%)	4.3	N/A
		Yes	X Walk 1 X Slope (%)	3.3	Yes
<p>Stop Condition-Street 2</p> <p>N/A</p>		Yes	Ramp inside XWalk1?	Yes	
		Yes	Any Obstructions?	No	
			Obstruction Type		
		Yes	Surface Condition? (G/P)	Good	
		N/A	Curb Slope (%)	19.3
