Access Compliance Report Public Rights-of-Way (Curb Ramps)

Intersection ID: 12950 Main Street: MORRIS_FIELD_DR Cross Street: SEYMOUR_DR Location: E

ADA ID: C784CF83C75D Ramp Type: PerpDiag Initial Pass/Fail: Fail Overall Compliance: No Severity Score: 10

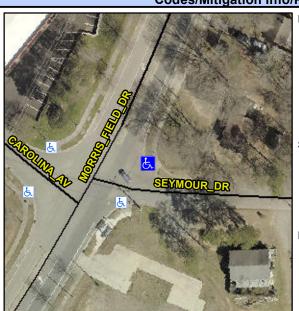
Not Found, R304.5.1, R304.5.3

Field Measurements/Component Compliance					
Compliance Description		Data	Com	oliance Description	Data
N	/A Ramp Length (in)	70.5	Yes	Ramp Slope (%)	5.2
N	• Ramp Width (in)	47.0	No	Ramp XSlope (%)	4.7
N/	/A Flare Type LT	N/A	N/A	Flare Type RT	N/A
N	/A Flare Slope LT (%)	N/A	N/A	Flare Slope RT (%)	N/A
N	/A Flare Traversable LT?	N/A	N/A	Flare Traversable RT?	N/A
N	/A Landing Length (in)	N/A	N/A	DWS Provided?	N/A
N	/A Landing Width (in)	N/A	N/A	DWS Contrast?	N/A
N	/A Landing Slope (%)	N/A	N/A	DWS Length (in)	N/A
N	/A Landing X Slope (%)	N/A	N/A	DWS Full Width?	N/A
N	/A Landing Curb? (Y/N)	N/A	N/A	DWS Offset (in)	N/A
N	/A Shared Landing?	N/A			
N	/A Gutter Ponding?	N/A	N/A	Gutter Slope (%)	N/A
N/	/A Gutter Lip Ht (in)	N/A	N/A	Gutter X Slope (%)	N/A
N	/A Painted X Walk1?	No	N/A	Painted X Walk2?	No
	X Walk 1 Direction	To NW		X Walk 2 Direction	To SW
N	/A X Walk 1 Width (in)	N/A	N/A	X Walk 2 Width (in)	N/A
	X Walk 1 Slope (%)	1.5		X Walk 2 Slope (%)	1.2

X Walk 1 X Slope (%)	3.7		X Walk 2 X Slope (%)	2.3
N	/A Ramp inside XWalk1?	N/A	N/A	Ramp inside XWalk2?	N/A
	Road Slope (%)	2.8	N/A	Clear Space?	N/A
	Road X Slope (%)	2.5	N/A	Clear Space to XWalk (in)	N/A
N	/A Any Obstructions?	N/A	N/A	Storm Grate/Utility Hazard?	N/A
	Obstruction Type			Storm Grate/Utility Type	
		N/A			N/A
			Yes	Surface Condition? (G/P)	Good

Remove & Replace Curb Ramp With Two New Directional Ramps or Equivalent.

Total Cost: \$ 3200.00
