Access Compliance Report Public Rights-of-Way (Curb Ramps)

Intersection ID: 27530 Main Street: BALLANTYNE_COMMONS_PY Cross Street: BALLANTYNE_FOREST_DR Location:									NW
ADA ID: C790518E43AE Ramp Type: Perp			initiai	Initial Pass/Fail: Fail Overall Compliance: No					1.25
Codes/Mitigation Info/Possible Solution				Field Measurements/Component Compliance					
ない	HE SU	Possible Solutions:		Compliance Description			Data Compliance Description		Data
		Remove & Replace Entire Ram	ıp.	N/A	Ramp Length (in)	107.0	Yes	Ramp Slope (%)	5.7

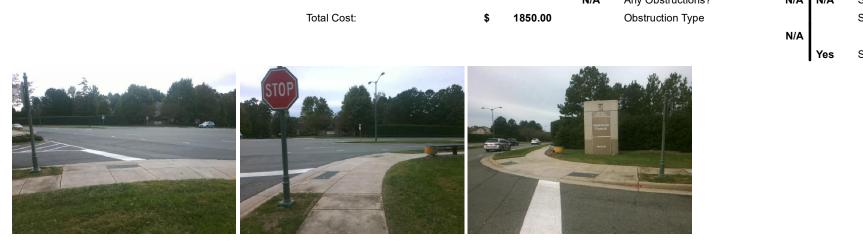
- 18 MA				Yes	Ramp Width (in)	49.0	No	Ramp XSlope (%)	2.1
15.2 100				N/A	Flare Type LT	N/A	N/A	Flare Type RT	N/A
- A. P.				N/A	Flare Slope LT (%)	N/A	N/A	Flare Slope RT (%)	N/A
A MARINE				N/A	Flare Traversable LT?	N/A	N/A	Flare Traversable RT?	N/A
				N/A	Landing Length (in)	N/A	N/A	DWS Provided?	N/A
	a da	Surveyor Notes:		N/A	Landing Width (in)	N/A	N/A	DWS Contrast?	N/A
Carlos Carlos 1	E.	N/A		N/A	Landing Slope (%)	N/A	N/A	DWS Length (in)	N/A
AND THE REAL PROPERTY OF			N/A	Landing X Slope (%)	N/A	N/A	DWS Full Width?	N/A	
MALE IN				N/A	Landing Curb? (Y/N)	N/A	N/A	DWS Offset (in)	N/A
and the second second	6		N/A	Shared Landing?	N/A				
BALLANU	1. 1. 20	PROW/ADA:		N/A	Gutter Ponding?	N/A	N/A	Gutter Slope (%)	N/A
and the second s	6	Not Found, R304.5.3		N/A	Gutter Lip Ht (in)	N/A	N/A	Gutter X Slope (%)	N/A
the state of the s				N/A	Painted X Walk1?	No	N/A	Painted X Walk2?	N/A
					X Walk 1 Direction	To E		X Walk 2 Direction	N/A
