Access Compliance Report

Public Rights-of-Way

(Curb Ramps)

Intersection ID: N/A	Main Street: INVERNESS_BAY_RD	Cross Street: OBAN_PASSAGE_DR	Location: NE
ADA ID: C791A2E7C0A7	Ramp Type: Perp	Initial Pass/Fail: Fail	Overall Compliance: No
Codes/Mitigation Info/Possible Solution		Field Measurements/Component Compliance	
Severity Score: 21.25

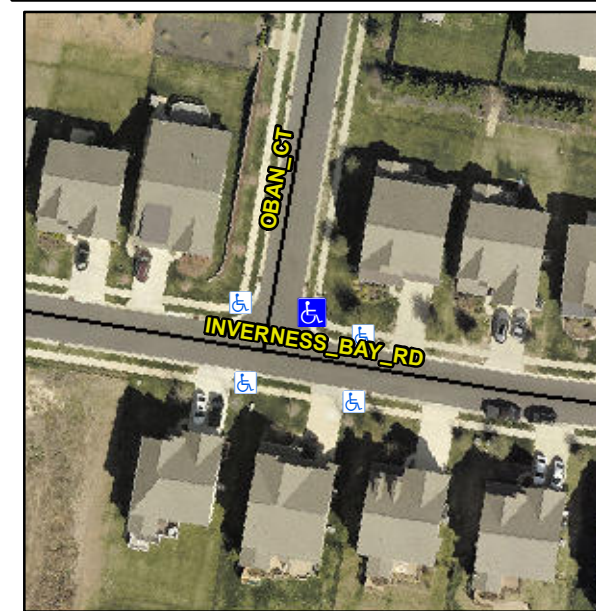
Not Found, R304.5.1, R304.5.3

Compliance	Description	Data	Compliance	Description	Data
N/A	Ramp Length (in)	48.0	Yes	Ramp Slope (%)	6.5
No	Ramp Width (in)	47.0	No	Ramp XSlope (%)	5.2
N/A	Flare Type LT	N/A	N/A	Flare Type RT	N/A
N/A	Flare Slope LT (%)	N/A	N/A	Flare Slope RT (%)	N/A
N/A	Flare Traversable LT?	N/A	N/A	Flare Traversable RT?	N/A
N/A	Landing Length (in)	N/A	N/A	DWS Provided?	N/A
N/A	Landing Width (in)	N/A	N/A	DWS Contrast?	N/A
N/A	Landing Slope (%)	N/A	N/A	DWS Length (in)	N/A
N/A	Landing X Slope (%)	N/A	N/A	DWS Full Width?	N/A
N/A	Landing Curb? (Y/N)	N/A	N/A	DWS Offset (in)	N/A
N/A	Shared Landing?	N/A			
N/A	Gutter Ponding?	N/A	N/A	Gutter Slope (%)	N/A
N/A	Gutter Lip Ht (in)	1.0	N/A	Gutter X Slope (%)	N/A
N/A	Painted X Walk1?	No	N/A	Painted X Walk2?	N/A
	X Walk 1 Direction	To NW		X Walk 2 Direction	N/A
N/A	X Walk 1 Width (in)	N/A	N/A	X Walk 2 Width (in)	N/A
	X Walk 1 Slope (%)	0.5		X Walk 2 Slope (%)	N/A
	X Walk 1 X Slope (%)	4.2		X Walk 2 X Slope (%)	N/A

Remove & Replace Entire Ramp.
