Access Compliance Report

Public Rights-of-Way

(Curb Ramps)

Intersection ID: 30017	Main Street: GREENBANK_CT	Cross Street: OLD_CAROLINA_DR	Location: E
ADA ID: C7B479FFFB39	Ramp Type: PerpDiag	Initial Pass/Fail: Fail	Overall Compliance: No
Severity Score: 37.5			
Codes/Mitigation Info/Possible Solution		Field Measurements/Component Compliance

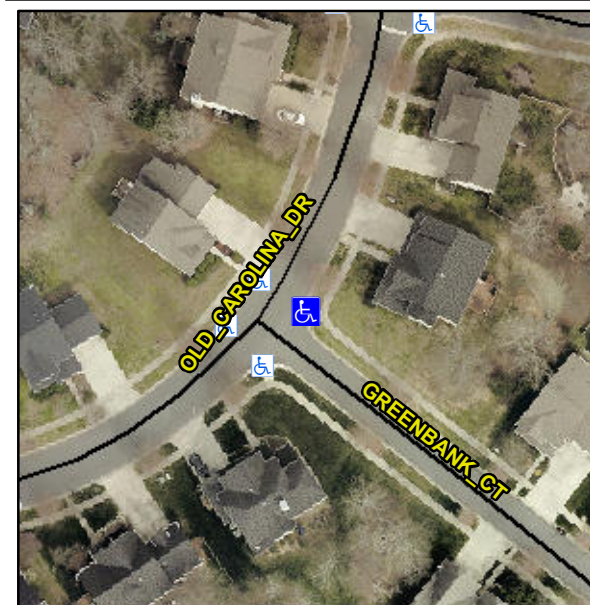
Not Found, R304.2.2, R304.5.3

Compliance	Description	Data	Compliance	Description	Data
N/A	Ramp Length (in)	86.0	No	Ramp Slope (%)	8.8
Yes	Ramp Width (in)	59.0	No	Ramp XSlope (%)	7.7
N/A	Flare Type LT	N/A	N/A	Flare Type RT	N/A
N/A	Flare Slope LT (%)	N/A	N/A	Flare Slope RT (%)	N/A
N/A	Flare Traversable LT?	N/A	N/A	Flare Traversable RT?	N/A
N/A	Landing Length (in)	N/A	N/A	DWS Provided?	N/A
N/A	Landing Width (in)	N/A	N/A	DWS Contrast?	N/A
N/A	Landing Slope (%)	N/A	N/A	DWS Length (in)	N/A
N/A	Landing X Slope (%)	N/A	N/A	DWS Full Width?	N/A
N/A	Landing Curb? (Y/N)	N/A	N/A	DWS Offset (in)	N/A
N/A	Shared Landing?	N/A			
N/A	Gutter Ponding?	N/A	N/A	Gutter Slope (%)	N/A
N/A	Gutter Lip Ht (in)	N/A	N/A	Gutter X Slope (%)	N/A
N/A	Painted X Walk1?	No	N/A	Painted X Walk2?	No
	X Walk 1 Direction	To NW		X Walk 2 Direction	To SW
N/A	X Walk 1 Width (in)	N/A	N/A	X Walk 2 Width (in)	N/A
	X Walk 1 Slope (%)	6.8		X Walk 2 Slope (%)	1.1
	X Walk 1 X Slope (%)	2.7		X Walk 2 X Slope (%)	4.3

N/A	Ramp inside XWalk1?	N/A	N/A	Ramp inside XWalk2?	N/A
	Road Slope (%)	4.3	N/A	Clear Space?	N/A
	Road X Slope (%)	2.6	N/A	Clear Space to XWalk (in)	N/A
N/A	Any Obstructions?	N/A	N/A	Storm Grate/Utility Hazard?	N/A
	Obstruction Type			Storm Grate/Utility Type	
		N/A			N/A
			Yes	Surface Condition? (G/P)	Good

Remove & Replace Curb Ramp With Two New Directional Ramps or Equivalent.
