# Access Compliance Report

## Public Rights-of-Way

### (Curb Ramps)

Intersection ID: 48198	Main Street: RIVERGATE_PY	Cross Street: S_TRYON_ST	Location: SW
ADA ID: C7D2EEB1924C	Ramp Type: Perp	Initial Pass/Fail: Fail	Overall Compliance: No
Codes/Mitigation Info/Possible Solution			Severity Score: 10
			Field Measurements/Component Compliance

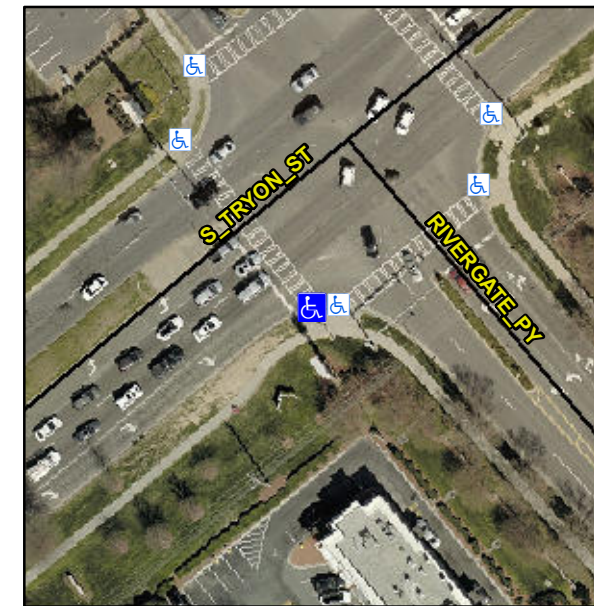
Compliance	Description	Data	Compliance	Description	Data
N/A	Ramp Length (in)	98.0	Yes	Ramp Slope (%)	6.2
No	Ramp Width (in)	47.0	Yes	Ramp XSlope (%)	4.1
N/A	Flare Type LT	N/A	N/A	Flare Type RT	N/A
N/A	Flare Slope LT (%)	N/A	N/A	Flare Slope RT (%)	N/A
N/A	Flare Traversable LT?	N/A	N/A	Flare Traversable RT?	N/A
N/A	Landing Length (in)	N/A	N/A	DWS Provided?	N/A
N/A	Landing Width (in)	N/A	N/A	DWS Contrast?	N/A
N/A	Landing Slope (%)	N/A	N/A	DWS Length (in)	N/A
N/A	Landing X Slope (%)	N/A	N/A	DWS Full Width?	N/A
N/A	Landing Curb? (Y/N)	N/A	N/A	DWS Offset (in)	N/A
N/A	Shared Landing?	N/A			
N/A	Gutter Ponding?	N/A	N/A	Gutter Slope (%)	N/A
N/A	Gutter Lip Ht (in)	N/A	N/A	Gutter X Slope (%)	N/A
N/A	Painted X Walk1?	Yes	N/A	Painted X Walk2?	N/A
	X Walk 1 Direction	To NW		X Walk 2 Direction	N/A
N/A	X Walk 1 Width (in)	105.0	N/A	X Walk 2 Width (in)	N/A
	X Walk 1 Slope (%)	3.2		X Walk 2 Slope (%)	N/A
	X Walk 1 X Slope (%)	4.1		X Walk 2 X Slope (%)	N/A

N/A	Ramp inside XWalk1?	Yes	N/A	Ramp inside XWalk2?	N/A
	Road Slope (%)	N/A	N/A	Clear Space?	N/A
	Road X Slope (%)	N/A	N/A	Clear Space to XWalk (in)	N/A
N/A	Any Obstructions?	N/A	N/A	Storm Grate/Utility Hazard?	N/A
	Obstruction Type			Storm Grate/Utility Type	
		N/A			N/A
			Yes	Surface Condition? (G/P)	Good

Possible Solutions:

**Remove & Replace Entire Ramp.**

**Not Found, R304.5.1**
