# Access Compliance Report

## Public Rights-of-Way

### (Curb Ramps)

Intersection ID: 27595	Main Street: BALLANTYNE COMMONS PY	Cross Street: BALLANTYNE MEADOWS DR	Location: NW
ADA ID: C7DF830D9F42	Ramp Type: Perp	Initial Pass/Fail: Fail	Overall Compliance: No
Severity Score: 21.25			
Codes/Mitigation Info/Possible Solution		Field Measurements/Component Compliance

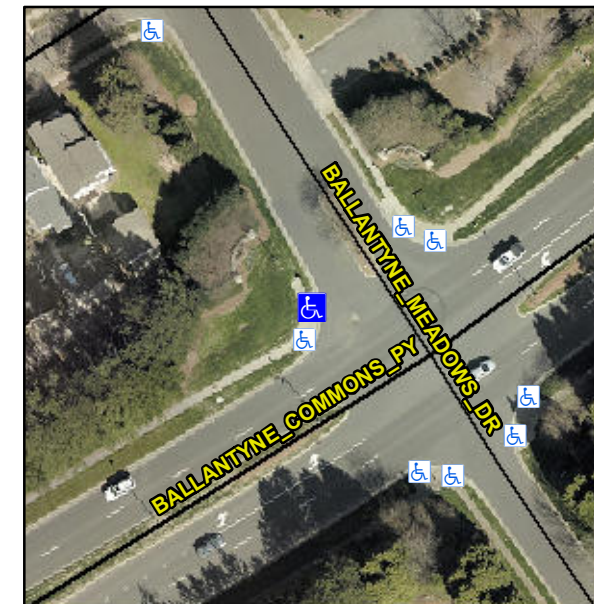
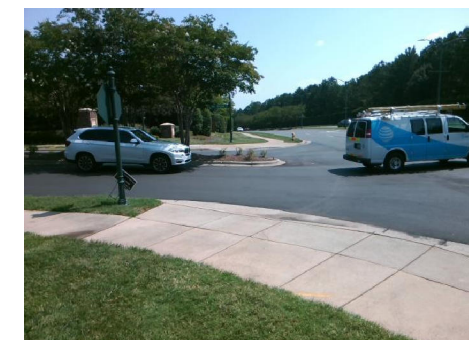
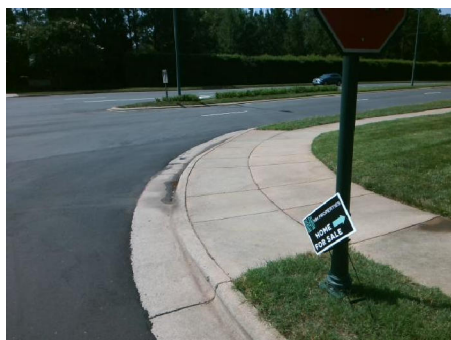
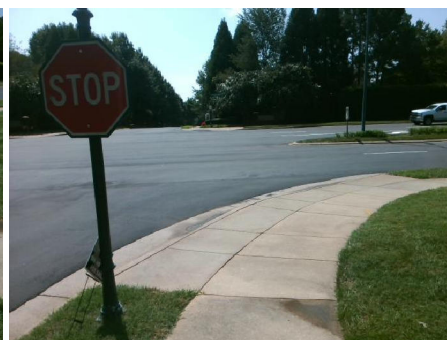
**Not Found, R304.5.1, R304.2.2**

Compliance	Description	Data	Compliance	Description	Data
N/A	Ramp Length (in)	109.0	No	Ramp Slope (%)	9.0
No	Ramp Width (in)	40.0	Yes	Ramp XSlope (%)	1.4
N/A	Flare Type LT	N/A	N/A	Flare Type RT	N/A
N/A	Flare Slope LT (%)	N/A	N/A	Flare Slope RT (%)	N/A
N/A	Flare Traversable LT?	N/A	N/A	Flare Traversable RT?	N/A
N/A	Landing Length (in)	N/A	N/A	DWS Provided?	N/A
N/A	Landing Width (in)	N/A	N/A	DWS Contrast?	N/A
N/A	Landing Slope (%)	N/A	N/A	DWS Length (in)	N/A
N/A	Landing X Slope (%)	N/A	N/A	DWS Full Width?	N/A
N/A	Landing Curb? (Y/N)	N/A	N/A	DWS Offset (in)	N/A
N/A	Shared Landing?	N/A			
N/A	Gutter Ponding?	N/A	N/A	Gutter Slope (%)	N/A
N/A	Gutter Lip Ht (in)	N/A	N/A	Gutter X Slope (%)	N/A
N/A	Painted X Walk1?	No	N/A	Painted X Walk2?	N/A
	X Walk 1 Direction	To NE		X Walk 2 Direction	N/A
N/A	X Walk 1 Width (in)	N/A	N/A	X Walk 2 Width (in)	N/A
	X Walk 1 Slope (%)	3.2		X Walk 2 Slope (%)	N/A
	X Walk 1 X Slope (%)	1.1		X Walk 2 X Slope (%)	N/A

N/A	Ramp inside XWalk1?	N/A	N/A	Ramp inside XWalk2?	N/A
	Road Slope (%)	N/A	N/A	Clear Space?	N/A
	Road X Slope (%)	N/A	N/A	Clear Space to XWalk (in)	N/A
N/A	Any Obstructions?	N/A	N/A	Storm Grate/Utility Hazard?	N/A
	Obstruction Type			Storm Grate/Utility Type	
		N/A			N/A
			Yes	Surface Condition? (G/P)	Good

**Remove & Replace Entire Ramp.**
