# Access Compliance Report

## Public Rights-of-Way

| Intersection ID: 31225 | Main Street: CLACKWYCK_LN | Cross Street: GRANTHAM_LN | Location: W |
| ADA ID: C7E73B821DE1 | Ramp Type: PerpDiag | Initial Pass/Fail: Fail | Overall Compliance: No |

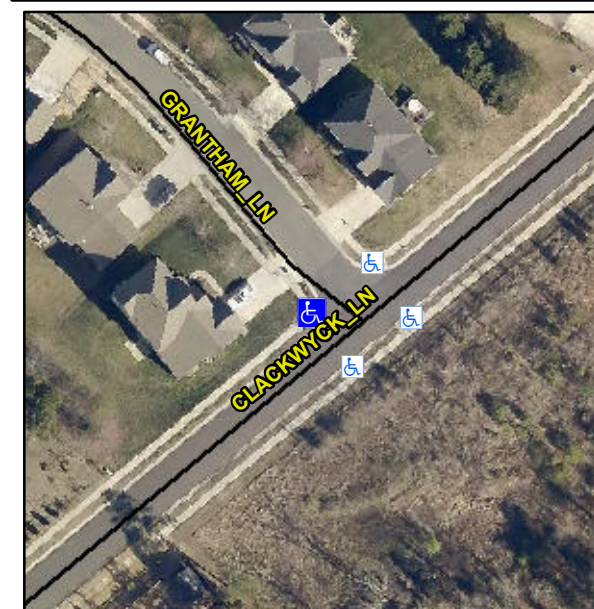
| Severity Score: 46.25 | | | |

**Not Found, R304.5.1, R304.2.2, R304.5.3**

| Compliance | Description | Data | Compliance | Description | Data |
|---|---|---|---|---|---|
| N/A | Ramp Length (in) | 48.0 | No | Ramp Slope (%) | 9.8 |
| No | Ramp Width (in) | 45.0 | No | Ramp XSlope (%) | 13.0 |

**Remove & Replace Curb Ramp With Two New Directional Ramps or Equivalent.**

Total Cost: \$ 3200.00
