# Access Compliance Report

## Public Rights-of-Way (Curb Ramps)

| Intersection ID: 30087 | Main Street: DEVONBRIDGE_LN | Cross Street: DEVONHILL_LN | Location: NW |
| ADA ID: C7F2B1BE6FB5 | Ramp Type: PerpDiag | Initial Pass/Fail: Pass | Overall Compliance: No<br>Severity Score: 15.25 |

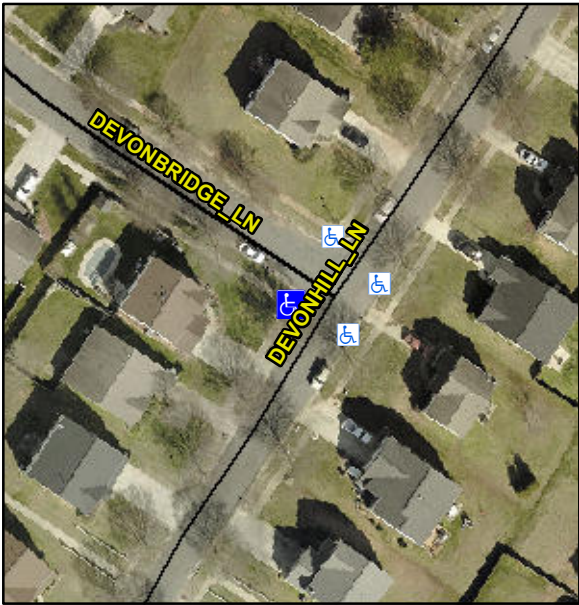
| Codes/Mitigation Info/Possible Solution | | | Field Measurements/Component Compliance | | | | | |
|---|---|---|---|---|---|---|---|---|
| | | | Yes | Ramp Width (in) | 48.0 | No | Ramp XSlope (%) | 4.8 |
| | | | No | Landing X Slope (%) | 7.1 | Yes | DWS Full Width? | Yes |
| PROW/ADA:<br><br><b>Not Found, R304.5.3, R305.2, R302.7, R302.7.2</b> | | N/A | Shared Landing? | No | | | | |
| | | No | Gutter Ponding? | Yes | Yes | Gutter Slope (%) | 2.2 | |
| | | No | Gutter Lip Ht (in) | 1.0 | No | Gutter X Slope (%) | 3.4 | |

| Codes/Mitigation Info/Possible Solution | | | Field Measurements/Component Compliance | | | | | |
|---|---|---|---|---|---|---|---|---|
| | <b>Remove &amp; Replace Curb Ramp With Two New Directional Ramps or Equivalent. Remove &amp; Replace Gutter.</b> | | N/A | Ramp Length (in) | 35.0 | Yes | Ramp Slope (%) | 5.7 |
