Intersection ID: 12134	Main Street: MARLOWE_AV	Cross Street: BERRYHILL_RD	Location:	SE
ADA ID: C7F7B1975930	Ramp Type: Perp	Initial Pass/Fail: Fail	Overall Compliance: No	Severity Score: 8.75

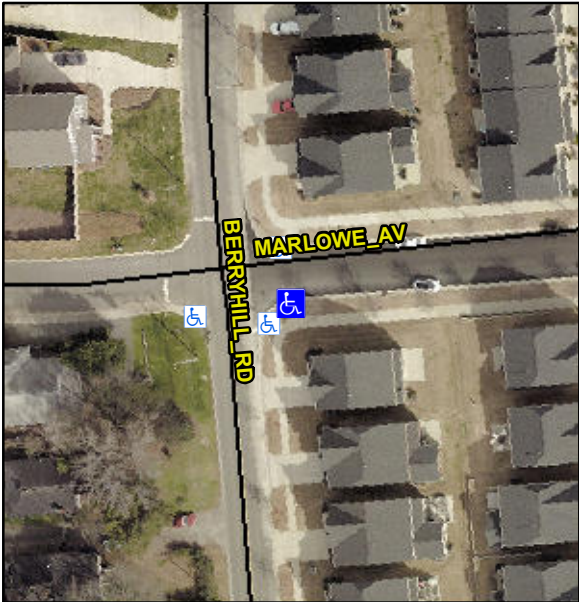
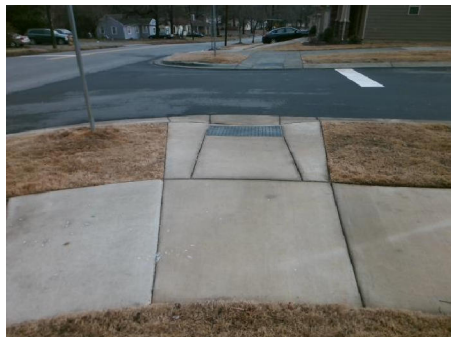
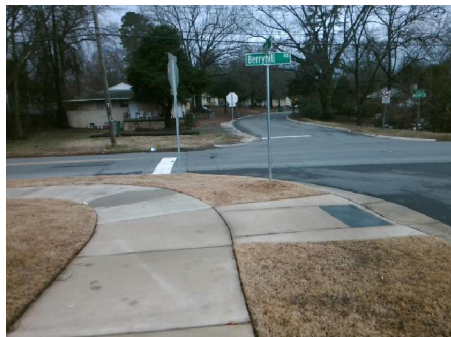
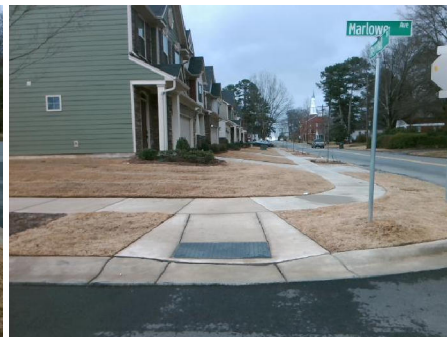
Possible Solutions:		Compliance	Description	Data	Compliance	Description	Data
	Remove & Replace Entire Ramp.		N/A	Ramp Length (in)	95.5	Yes	Ramp Slope (%)	5.4
			No	Ramp Width (in)	47.0	Yes	Ramp XSlope (%)	0.2
			N/A	Flare Type LT	N/A	N/A	Flare Type RT	N/A
			N/A	Flare Slope LT (%)	N/A	N/A	Flare Slope RT (%)	N/A
			N/A	Flare Traversable LT?	N/A	N/A	Flare Traversable RT?	N/A
			N/A	Landing Length (in)	N/A	N/A	DWS Provided?	N/A
	Surveyor Notes:		N/A	Landing Width (in)	N/A	N/A	DWS Contrast?	N/A
			N/A	Landing Slope (%)	N/A	N/A	DWS Length (in)	N/A
			N/A	Landing X Slope (%)	N/A	N/A	DWS Full Width?	N/A
			N/A	Landing Curb? (Y/N)	N/A	N/A	DWS Offset (in)	N/A
			N/A	Shared Landing?	N/A			
			N/A	Gutter Ponding?	N/A	N/A	Gutter Slope (%)	N/A
			N/A	Gutter Lip Ht (in)	N/A	N/A	Gutter X Slope (%)	N/A
			N/A	Painted X Walk1?	No	N/A	Painted X Walk2?	N/A

X Walk 1 Direction	To N		X Walk 2 Direction	N/A
			N/A	X Walk 1 Width (in)	N/A	N/A	X Walk 2 Width (in)	N/A
				X Walk 1 Slope (%)	4.0		X Walk 2 Slope (%)	N/A
				X Walk 1 X Slope (%)	1.4		X Walk 2 X Slope (%)	N/A
			N/A	Ramp inside XWalk1?	N/A	N/A	Ramp inside XWalk2?	N/A
				Road Slope (%)	N/A	N/A	Clear Space?	N/A
				Road X Slope (%)	N/A	N/A	Clear Space to XWalk (in)	N/A
			N/A	Any Obstructions?	N/A	N/A	Storm Grate/Utility Hazard?	N/A
				Obstruction Type			Storm Grate/Utility Type	
					N/A			N/A
						Yes	Surface Condition? (G/P)	Good
	Total Cost:	\$ 1850.00
