Intersection ID: 7570	Main Street: BEATTIES_FORD_RD	Cross Street: SIR_BAILEY_DR	Location:	SW
ADA ID: C7FCDAEA2901	Ramp Type: Perp	Initial Pass/Fail: Fail	Overall Compliance: No	Severity Score: 13.75

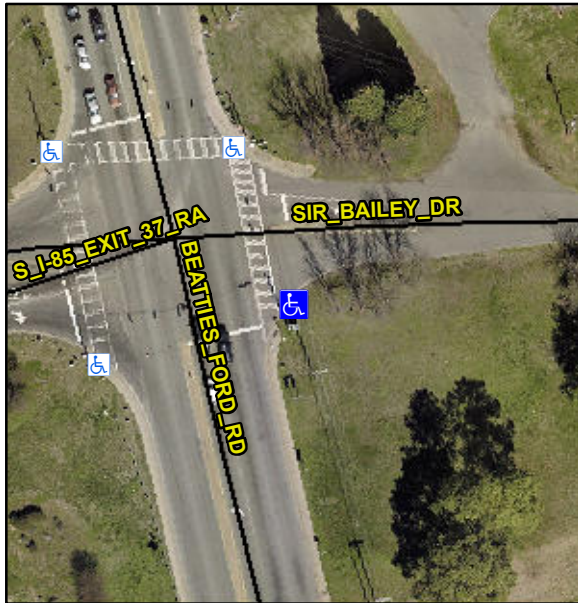
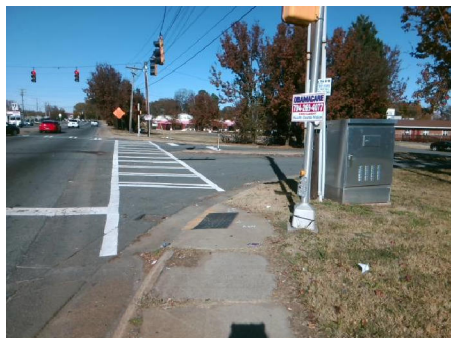
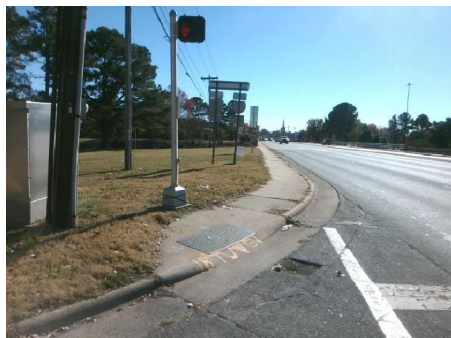
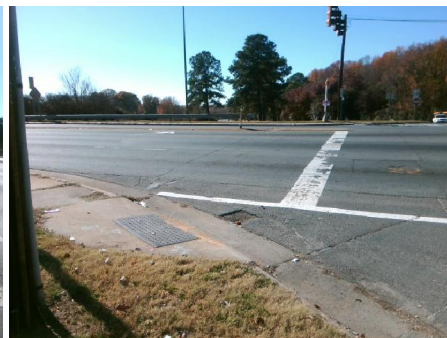
R304.2.2

Compliance	Description	Data	Compliance	Description	Data
N/A	Ramp Length (in)	65.0	No	Ramp Slope (%)	10.9
Yes	Ramp Width (in)	48.0	Yes	Ramp XSlope (%)	2.1
N/A	Flare Type LT	N/A	N/A	Flare Type RT	N/A
N/A	Flare Slope LT (%)	N/A	N/A	Flare Slope RT (%)	N/A
N/A	Flare Traversable LT?	N/A	N/A	Flare Traversable RT?	N/A
N/A	Landing Length (in)	N/A	N/A	DWS Provided?	N/A
N/A	Landing Width (in)	N/A	N/A	DWS Contrast?	N/A
N/A	Landing Slope (%)	N/A	N/A	DWS Length (in)	N/A
N/A	Landing X Slope (%)	N/A	N/A	DWS Full Width?	N/A
N/A	Landing Curb? (Y/N)	N/A	N/A	DWS Offset (in)	N/A
N/A	Shared Landing?	N/A			
N/A	Gutter Ponding?	N/A	N/A	Gutter Slope (%)	N/A
N/A	Gutter Lip Ht (in)	N/A	N/A	Gutter X Slope (%)	N/A
N/A	Painted X Walk1?	Yes	N/A	Painted X Walk2?	N/A
	X Walk 1 Direction	To N		X Walk 2 Direction	N/A
N/A	X Walk 1 Width (in)	106.0	N/A	X Walk 2 Width (in)	N/A
	X Walk 1 Slope (%)	1.4		X Walk 2 Slope (%)	N/A
	X Walk 1 X Slope (%)	4.6		X Walk 2 X Slope (%)	N/A

N/A	Ramp inside XWalk1?	Yes	N/A	Ramp inside XWalk2?	N/A
	Road Slope (%)	N/A	N/A	Clear Space?	N/A
	Road X Slope (%)	N/A	N/A	Clear Space to XWalk (in)	N/A
N/A	Any Obstructions?	N/A	N/A	Storm Grate/Utility Hazard?	N/A
	Obstruction Type			Storm Grate/Utility Type	
		N/A			N/A
			Yes	Surface Condition? (G/P)	Good

Remove & Replace Entire Ramp.

Total Cost: \$ 1850.00
