Access Compliance Report Public Rights-of-Way (Curb Ramps)

· · · ·									
Intersection ID: 17353	Main Street: JAMESTON_DR			Street:	LYNNWOOD_DR	Location:	NE		
ADA ID: C8108240D1D2	Ramp Ty	Ramp Type: PerpDiag			ail: Fail Overall C	o Severity Score:	22.5		
Codes/Mitigation Info/Possible Solution				Field Measurements/Component Compliance					
		Possible Solutions:		Compliance Description			Data Compliance Description		Data
		Remove & Replace Curb Ramp \	With	N/A	Ramp Length (in)	68.0	No	Ramp Slope (%)	9.6
		Two New Directional Ramps or		No	Ramp Width (in)	37.0	No	Ramp XSlope (%)	2.6
		Equivalent.		N/A	Flare Type LT	N/A	N/A	Flare Type RT	N/A
				N/A	Flare Slope LT (%)	N/A	N/A	Flare Slope RT (%)	N/A
				N/A	Flare Traversable LT?	N/A	N/A	Flare Traversable RT?	N/A
				N/A	Landing Length (in)	N/A	N/A	DWS Provided?	N/A
EU CAR		Surveyor Notes:		N/A	Landing Width (in)	N/A	N/A	DWS Contrast?	N/A
E E		N/A		N/A	Landing Slope (%)	N/A	N/A	DWS Length (in)	N/A
LTMINWOOD				N/A	Landing X Slope (%)	N/A	N/A	DWS Full Width?	N/A

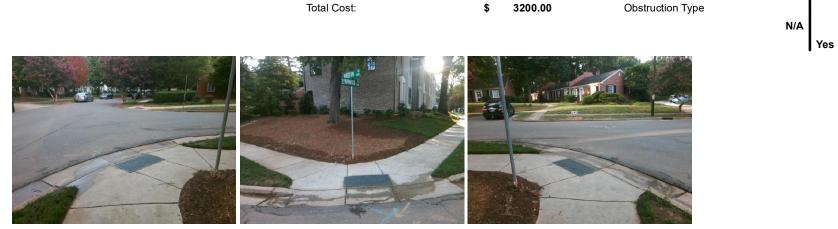
N/A	Landing Curb? (Y/N)	N/A	N/A	DWS Offset (in)	N/A
G G				N/A	Shared Landing?	N/A			
The second second	Contraction of the second	PROW/ADA:		N/A	Gutter Ponding?	N/A	N/A	Gutter Slope (%)	N/A
	FORM & M	Not Found, R304.5.1, R304.2.2 R304.5.3		N/A	Gutter Lip Ht (in)	N/A	N/A	Gutter X Slope (%)	N/A
				N/A	Painted X Walk1?	No	N/A	Painted X Walk2?	No
				X Walk 1 Direction	To W		X Walk 2 Direction	To S	
The first of the second				N/A	X Walk 1 Width (in)	N/A	N/A	X Walk 2 Width (in)	N/A
Street 1 Name	JAMESTON DR				X Walk 1 Slope (%)	3.1		X Walk 2 Slope (%)	0.3
Stop Condition-Street 2	StopSign				X Walk 1 X Slope (%)	0.7		X Walk 2 X Slope (%)	1.4
Street 2 Name	LYNNWOOD DR			N/A	Ramp inside XWalk1?	N/A	N/A	Ramp inside XWalk2?	N/A
Stop Condition-Street 1	None				Road Slope (%)	1.7	N/A	Clear Space?	N/A
					Road X Slope (%)	0.2	N/A	Clear Space to XWalk (in)	N/A
				N/A	Any Obstructions?	N/A	N/A	Storm Grate/Utility Hazard?	N/A

s Surface Condition? (G/P)

Good

Total Cost: \$	3200.00		Obstruction Type			Storm Grate/Utility Type	
						N/A			N/A
