Access Compliance Report

Public Rights-of-Way

(Curb Ramps)

Intersection ID: 32027	Main Street: COLONIAL_REA_CT	Cross Street: STONECROFT_PARK_DR	Location: NW
ADA ID: C8217EEFFD62	Ramp Type: PerpDiag	Initial Pass/Fail: Fail	Overall Compliance: No
Severity Score: 42.5			
Codes/Mitigation Info/Possible Solution		Field Measurements/Component Compliance

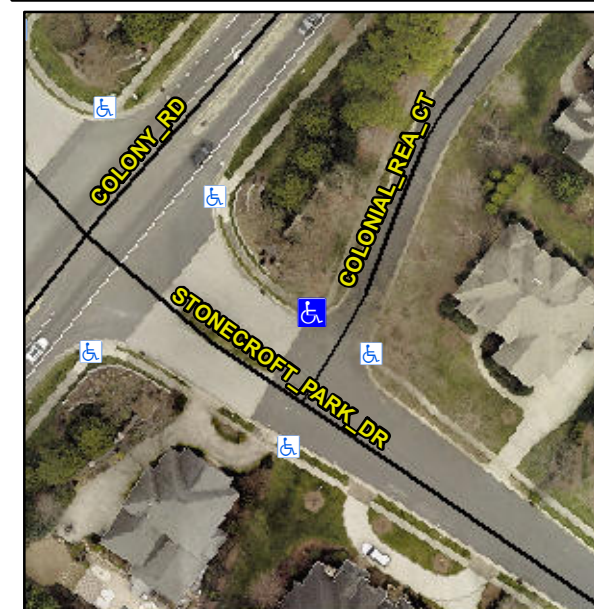
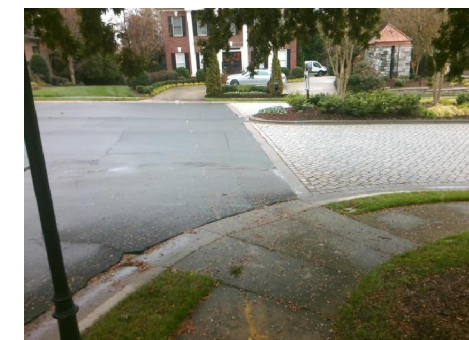
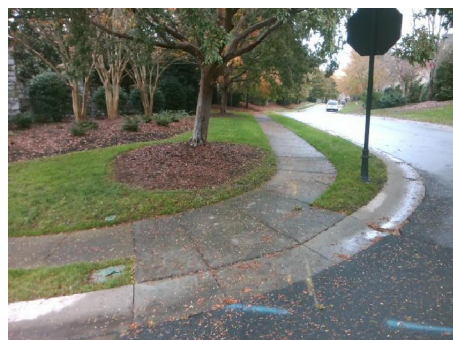
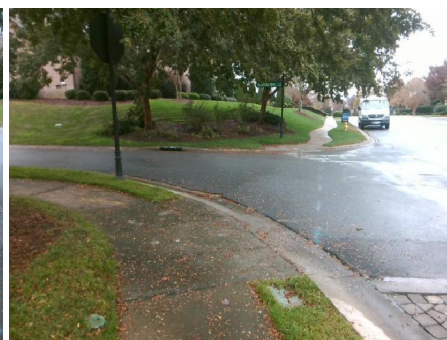
Not Found, R304.5.1, R304.5.3

Compliance	Description	Data	Compliance	Description	Data
N/A	Ramp Length (in)	72.0	Yes	Ramp Slope (%)	6.8
No	Ramp Width (in)	32.0	No	Ramp XSlope (%)	10.4
N/A	Flare Type LT	N/A	N/A	Flare Type RT	N/A
N/A	Flare Slope LT (%)	N/A	N/A	Flare Slope RT (%)	N/A
N/A	Flare Traversable LT?	N/A	N/A	Flare Traversable RT?	N/A
N/A	Landing Length (in)	N/A	N/A	DWS Provided?	N/A
N/A	Landing Width (in)	N/A	N/A	DWS Contrast?	N/A
N/A	Landing Slope (%)	N/A	N/A	DWS Length (in)	N/A
N/A	Landing X Slope (%)	N/A	N/A	DWS Full Width?	N/A
N/A	Landing Curb? (Y/N)	N/A	N/A	DWS Offset (in)	N/A
N/A	Shared Landing?	N/A			
N/A	Gutter Ponding?	N/A	N/A	Gutter Slope (%)	N/A
N/A	Gutter Lip Ht (in)	N/A	N/A	Gutter X Slope (%)	N/A
N/A	Painted X Walk1?	No	N/A	Painted X Walk2?	No
	X Walk 1 Direction	To SE		X Walk 2 Direction	To SW
N/A	X Walk 1 Width (in)	N/A	N/A	X Walk 2 Width (in)	N/A
	X Walk 1 Slope (%)	0.3		X Walk 2 Slope (%)	5.7
	X Walk 1 X Slope (%)	6.0		X Walk 2 X Slope (%)	6.5

N/A	Ramp inside XWalk1?	N/A	N/A	Ramp inside XWalk2?	N/A
	Road Slope (%)	6.5	N/A	Clear Space?	N/A
	Road X Slope (%)	1.9	N/A	Clear Space to XWalk (in)	N/A
N/A	Any Obstructions?	N/A	N/A	Storm Grate/Utility Hazard?	N/A
	Obstruction Type			Storm Grate/Utility Type	
		N/A			N/A
			Yes	Surface Condition? (G/P)	Good

Possible Solutions:

Remove & Replace Curb Ramp With Two New Directional Ramps or Equivalent.
