# Access Compliance Report

## Public Rights-of-Way

### (Curb Ramps)

Intersection ID: 9489		Main Street: STATESVILLE_AV		Cross Street: KOHLER_AV		Location: SE			
ADA ID: C821A4D1948B		Ramp Type: Perp		Initial Pass/Fail: Fail		Overall Compliance: No		Severity Score: 22.5	
Codes/Mitigation Info/Possible Solution					Field Measurements/Component Compliance

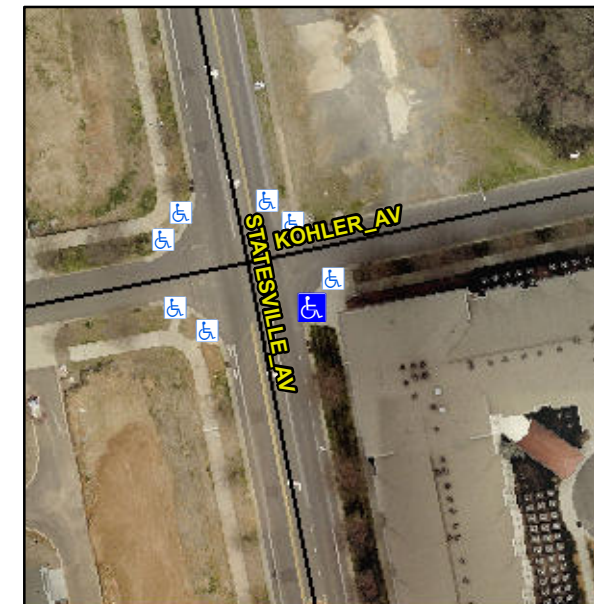
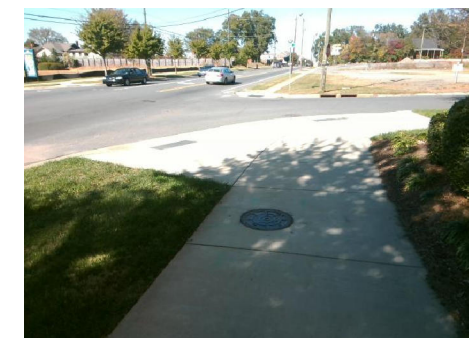
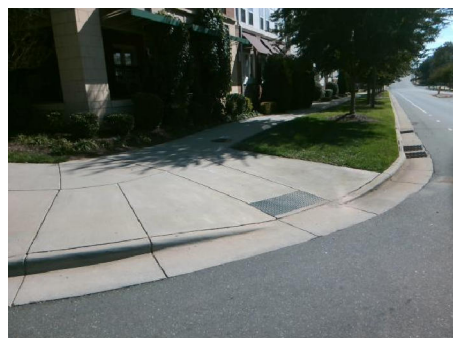
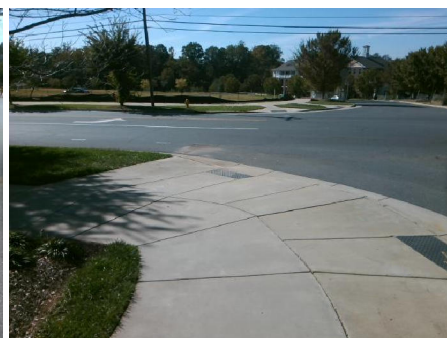
Compliance	Description	Data	Compliance	Description	Data
N/A	Ramp Length (in)	119.0	No	Ramp Slope (%)	9.0
No	Ramp Width (in)	47.0	No	Ramp XSlope (%)	4.7
N/A	Flare Type LT	N/A	N/A	Flare Type RT	N/A
N/A	Flare Slope LT (%)	N/A	N/A	Flare Slope RT (%)	N/A
N/A	Flare Traversable LT?	N/A	N/A	Flare Traversable RT?	N/A
N/A	Landing Length (in)	N/A	N/A	DWS Provided?	N/A
N/A	Landing Width (in)	N/A	N/A	DWS Contrast?	N/A
N/A	Landing Slope (%)	N/A	N/A	DWS Length (in)	N/A
N/A	Landing X Slope (%)	N/A	N/A	DWS Full Width?	N/A
N/A	Landing Curb? (Y/N)	N/A	N/A	DWS Offset (in)	N/A
N/A	Shared Landing?	N/A			
N/A	Gutter Ponding?	N/A	N/A	Gutter Slope (%)	N/A
N/A	Gutter Lip Ht (in)	N/A	N/A	Gutter X Slope (%)	N/A
N/A	Painted X Walk1?	No	N/A	Painted X Walk2?	N/A
	X Walk 1 Direction	To W		X Walk 2 Direction	N/A
N/A	X Walk 1 Width (in)	N/A	N/A	X Walk 2 Width (in)	N/A
	X Walk 1 Slope (%)	3.8		X Walk 2 Slope (%)	N/A
	X Walk 1 X Slope (%)	3.0		X Walk 2 X Slope (%)	N/A

N/A	Ramp inside XWalk1?	N/A	N/A	Ramp inside XWalk2?	N/A
	Road Slope (%)	N/A	N/A	Clear Space?	N/A
	Road X Slope (%)	N/A	N/A	Clear Space to XWalk (in)	N/A
N/A	Any Obstructions?	N/A	N/A	Storm Grate/Utility Hazard?	N/A
	Obstruction Type			Storm Grate/Utility Type	
		N/A			N/A
			Yes	Surface Condition? (G/P)	Good

Possible Solutions:

**Remove & Replace Entire Ramp.**

**R304.5.1, R304.2.2, R304.5.3**

Total Cost: \$ 1850.00
