Access Compliance Report

Public Rights-of-Way

(Curb Ramps)

Intersection ID: 9409	Main Street: THRIFTWOOD_DR	Cross Street: N/A	Location: S
ADA ID: C8222DA4AEF5	Ramp Type: Perp	Initial Pass/Fail: Fail	Overall Compliance: No
		Severity Score: 10

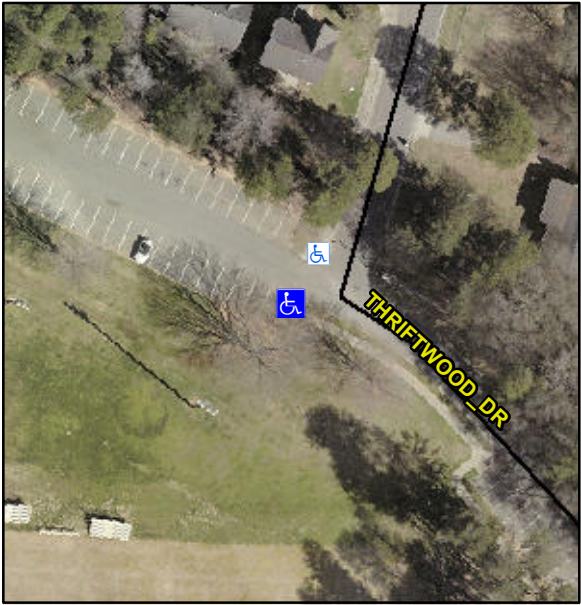
Possible Solutions:		Compliance	Description	Data	Compliance
	Remove & Replace Entire Ramp.		Yes	Ramp Length (in)	56.0	Description
			No	Ramp Width (in)	47.5	Ramp XSlope (%)
			N/A	Flare Type LT	N/A	Flare Type RT
			N/A	Flare Slope LT (%)	N/A	Flare Slope RT (%)
			N/A	Flare Traversable LT?	N/A	Flare Traversable RT?
			N/A	Landing Length (in)	N/A	DWS Provided?
			N/A	Landing Width (in)	N/A	DWS Contrast?
			N/A	Landing Slope (%)	N/A	DWS Length (in)
			N/A	Landing X Slope (%)	N/A	DWS Full Width?
			N/A	Landing Curb? (Y/N)	N/A	DWS Offset (in)
			N/A	Shared Landing?	N/A	
			N/A	Gutter Ponding?	N/A	Gutter Slope (%)
			N/A	Gutter Lip Ht (in)	N/A	Gutter X Slope (%)
			N/A	Painted X Walk1?	No	Painted X Walk2?
				X Walk 1 Direction	To NE	X Walk 2 Direction
			N/A	X Walk 1 Width (in)	N/A	X Walk 2 Width (in)
				X Walk 1 Slope (%)	1.0	X Walk 2 Slope (%)

X Walk 1 X Slope (%)	2.6	X Walk 2 X Slope (%)
			N/A	Ramp inside XWalk1?	N/A	Ramp inside XWalk2?
<p>Surveyor Notes:</p> <p>N/A</p> <p>PROW/ADA:</p> <p>Not Found, R304.5.1, R304.5.3</p>			N/A	Road Slope (%)	N/A	Clear Space?
			N/A	Road X Slope (%)	N/A	Clear Space to XWalk (in)
			N/A	Any Obstructions?	N/A	Storm Grate/Utility Hazard?
				Obstruction Type		Storm Grate/Utility Type
			N/A			
			N/A			
			Yes	Surface Condition? (G/P)		Good
