Access Compliance Report

Public Rights-of-Way

(Curb Ramps)

Intersection ID: 19937	Main Street: S_TRYON_ST	Cross Street: THORNFIELD_RD	Location: NW
ADA ID: C824D7CDB9E6	Ramp Type: Perp	Initial Pass/Fail: Fail	Overall Compliance: No
		Severity Score: 12.5

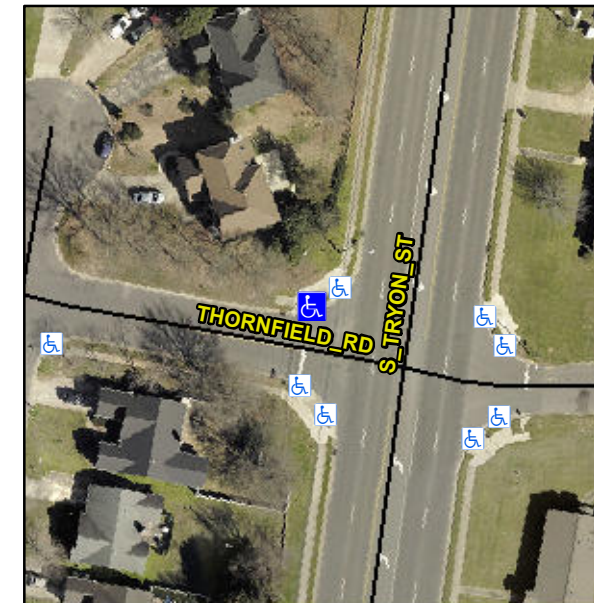
Not Found, R304.2.2

Compliance	Description	Data	Compliance	Description	Data
N/A	Ramp Length (in)	89.0	No	Ramp Slope (%)	8.4
Yes	Ramp Width (in)	48.0	Yes	Ramp XSlope (%)	2.0
N/A	Flare Type LT	N/A	N/A	Flare Type RT	N/A
N/A	Flare Slope LT (%)	N/A	N/A	Flare Slope RT (%)	N/A
N/A	Flare Traversable LT?	N/A	N/A	Flare Traversable RT?	N/A
N/A	Landing Length (in)	N/A	N/A	DWS Provided?	N/A
N/A	Landing Width (in)	N/A	N/A	DWS Contrast?	N/A
N/A	Landing Slope (%)	N/A	N/A	DWS Length (in)	N/A
N/A	Landing X Slope (%)	N/A	N/A	DWS Full Width?	N/A
N/A	Landing Curb? (Y/N)	N/A	N/A	DWS Offset (in)	N/A
N/A	Shared Landing?	N/A			
N/A	Gutter Ponding?	N/A	N/A	Gutter Slope (%)	N/A
N/A	Gutter Lip Ht (in)	N/A	N/A	Gutter X Slope (%)	N/A
N/A	Painted X Walk1?	No	N/A	Painted X Walk2?	N/A
	X Walk 1 Direction	To S		X Walk 2 Direction	N/A
N/A	X Walk 1 Width (in)	N/A	N/A	X Walk 2 Width (in)	N/A
	X Walk 1 Slope (%)	1.2		X Walk 2 Slope (%)	N/A
	X Walk 1 X Slope (%)	2.6		X Walk 2 X Slope (%)	N/A

N/A	Ramp inside XWalk1?	N/A	N/A	Ramp inside XWalk2?	N/A
	Road Slope (%)	N/A	N/A	Clear Space?	N/A
	Road X Slope (%)	N/A	N/A	Clear Space to XWalk (in)	N/A
N/A	Any Obstructions?	N/A	N/A	Storm Grate/Utility Hazard?	N/A
	Obstruction Type			Storm Grate/Utility Type	
		N/A			N/A
			Yes	Surface Condition? (G/P)	Good

Possible Solutions:

Remove & Replace Entire Ramp.

Total Cost: \$ 1850.00
