# Access Compliance Report

## Public Rights-of-Way

Intersection ID: N/A	Main Street: ROCKY_RIVER_RD	Cross Street: JOHN_RUSSELL_RD	Location: SE
ADA ID: C836E31AD171	Ramp Type: Perp	Initial Pass/Fail: Fail	Overall Compliance: No
Severity Score: 22.5			
Codes/Mitigation Info/Possible Solution		Field Measurements/Component Compliance

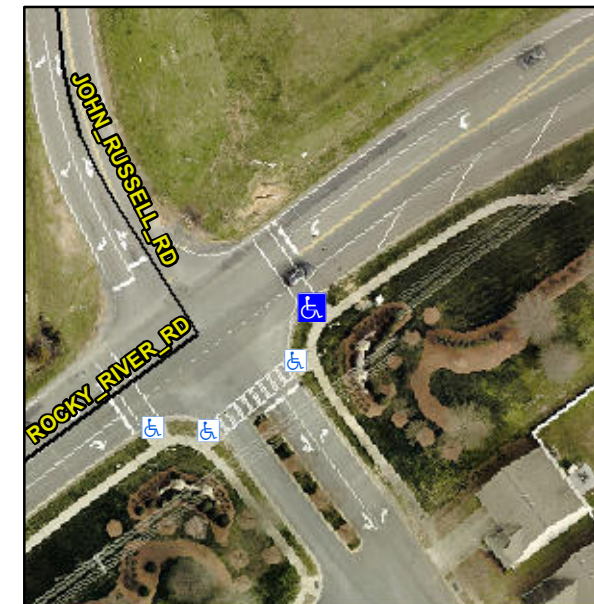
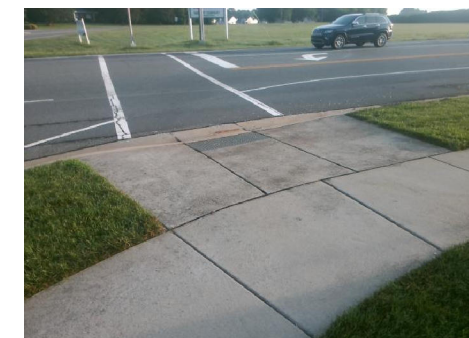
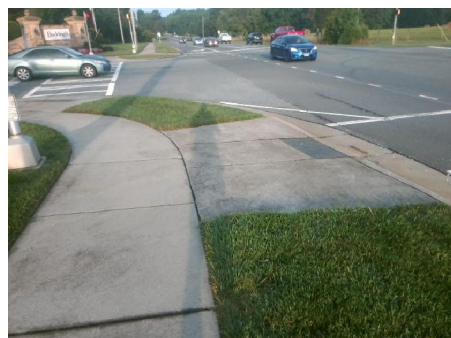
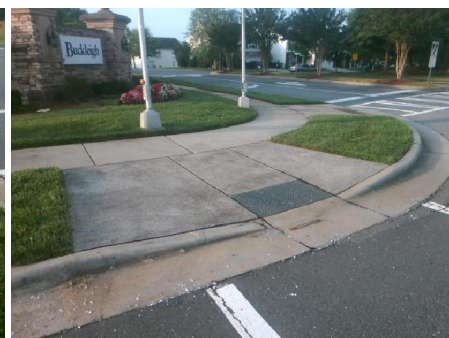
**Not Found, R304.5.1, R304.2.2, R304.5.3**

Compliance	Description	Data	Compliance	Description	Data
N/A	Ramp Length (in)	96.0	No	Ramp Slope (%)	9.4
No	Ramp Width (in)	46.0	No	Ramp XSlope (%)	3.1
N/A	Flare Type LT	N/A	N/A	Flare Type RT	N/A
N/A	Flare Slope LT (%)	N/A	N/A	Flare Slope RT (%)	N/A
N/A	Flare Traversable LT?	N/A	N/A	Flare Traversable RT?	N/A
N/A	Landing Length (in)	N/A	N/A	DWS Provided?	N/A
N/A	Landing Width (in)	N/A	N/A	DWS Contrast?	N/A
N/A	Landing Slope (%)	N/A	N/A	DWS Length (in)	N/A
N/A	Landing X Slope (%)	N/A	N/A	DWS Full Width?	N/A
N/A	Landing Curb? (Y/N)	N/A	N/A	DWS Offset (in)	N/A
N/A	Shared Landing?	N/A			
N/A	Gutter Ponding?	N/A	N/A	Gutter Slope (%)	N/A
N/A	Gutter Lip Ht (in)	N/A	N/A	Gutter X Slope (%)	N/A
N/A	Painted X Walk1?	Yes	N/A	Painted X Walk2?	N/A
	X Walk 1 Direction	To NW		X Walk 2 Direction	N/A
N/A	X Walk 1 Width (in)	110.0	N/A	X Walk 2 Width (in)	N/A
	X Walk 1 Slope (%)	3.6		X Walk 2 Slope (%)	N/A
	X Walk 1 X Slope (%)	1.2		X Walk 2 X Slope (%)	N/A

N/A	Ramp inside XWalk1?	Yes	N/A	Ramp inside XWalk2?	N/A
	Road Slope (%)	N/A	N/A	Clear Space?	N/A
	Road X Slope (%)	N/A	N/A	Clear Space to XWalk (in)	N/A
N/A	Any Obstructions?	N/A	N/A	Storm Grate/Utility Hazard?	N/A
	Obstruction Type			Storm Grate/Utility Type	
		N/A			N/A
			Yes	Surface Condition? (G/P)	Good

**Remove & Replace Entire Ramp.**
