Access Compliance Report

Public Rights-of-Way

(Curb Ramps)

Intersection ID: N/A	Main Street: CONFERENCE_DR	Cross Street: OLD_POST_RD	Location: NW
ADA ID: C84337D7A67F	Ramp Type: Directional1	Initial Pass/Fail: Fail	Overall Compliance: No
Severity Score: 12.5			
Codes/Mitigation Info/Possible Solution		Field Measurements/Component Compliance

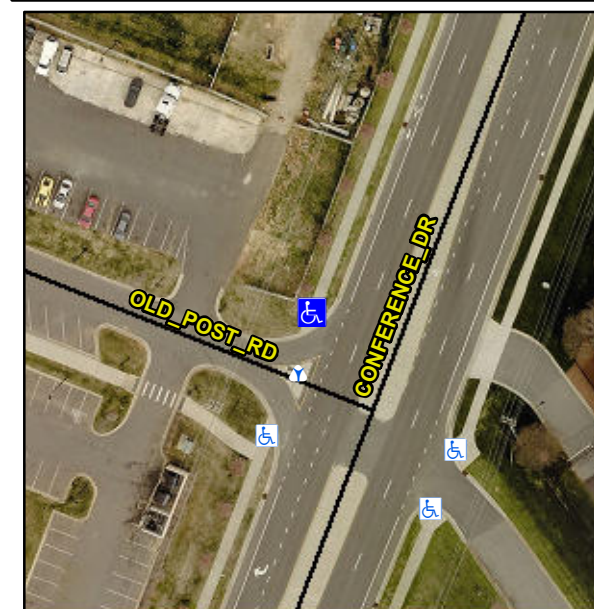
Compliance	Description	Data	Compliance	Description	Data
N/A	Ramp Length (in)	69.0	N/A	Grade Break?	N/A
Yes	Ramp Width (in)	69.0	N/A	Grade Break Slope (%)	0.0
No	Ramp Slope (%)	9.1	N/A	Grade Break XSlope (%)	0.0
Yes	Ramp XSlope (%)	1.1			
N/A	Flare Type LT	N/A	N/A	Flare Type RT	N/A
N/A	Flare Slope LT (%)	N/A	N/A	Flare Slope RT (%)	0.0
N/A	Flare Traversable LT?	N/A	N/A	Flare Traversable RT?	N/A
N/A	Landing Length (in)	0.0	N/A	DWS Provided?	N/A
N/A	Landing Width (in)	0.0	N/A	DWS Contrast?	N/A
N/A	Landing Slope (%)	0.0	N/A	DWS Length (in)	N/A
N/A	Landing X Slope (%)	0.0	N/A	DWS Full Width?	N/A
N/A	Landing Curb? (Y/N)	N/A	N/A	DWS Offset LT (in)	N/A
N/A	Shared Landing?	N/A	N/A	DWS Offset RT (in)	N/A
N/A	Gutter Ponding?	0.0	N/A	Gutter Slope (%)	N/A
N/A	Gutter Lip Ht (in)	0.0	N/A	Gutter X Slope (%)	N/A
N/A	Painted X Walk1?	No		Road Slope (%)	0.6
	X Walk 1 Direction	To S		Road X Slope (%)	2.8
	X Walk 1 Width (in)	N/A		Clear Space?	N/A

X Walk 1 Slope (%)	0.6	N/A	Clear Space to XWalk (in)	N/A
	X Walk 1 X Slope (%)	2.8	N/A	Storm Grate/Utility Hazard?	N/A
N/A	Ramp inside XWalk1?	N/A		Storm Grate/Utility Type	
N/A	Any Obstructions?	N/A			N/A
	Obstruction Type		Yes	Surface Condition? (G/P)	Good
			N/A	Curb Slope (%)	3.5

Possible Solutions:

Remove & Replace Entire Ramp.

R304.2.2

\$ 1600.00
