Access Compliance Report

Public Rights-of-Way

(Curb Ramps)

Intersection ID: 10141	Main Street: MILL_RD	Cross Street: W_TRADE_ST	Location:	N
ADA ID: C849326932BA	Ramp Type: Perp	Initial Pass/Fail: Fail	Overall Compliance: No	Severity Score: 12.5
Codes/Mitigation Info/Possible Solution		Field Measurements/Component Compliance

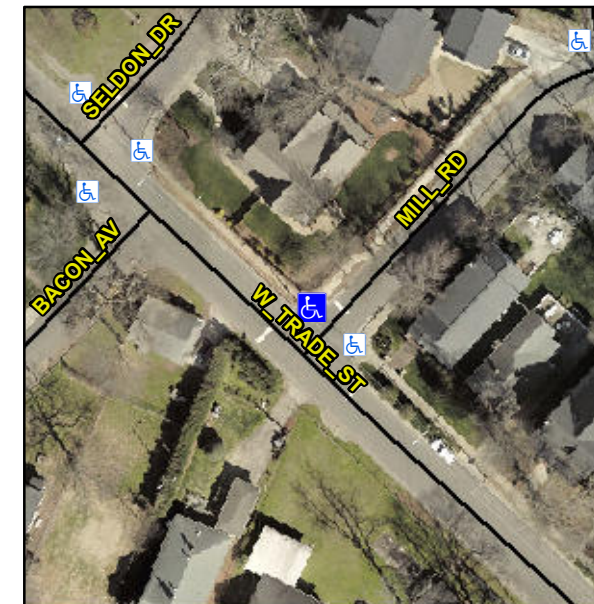
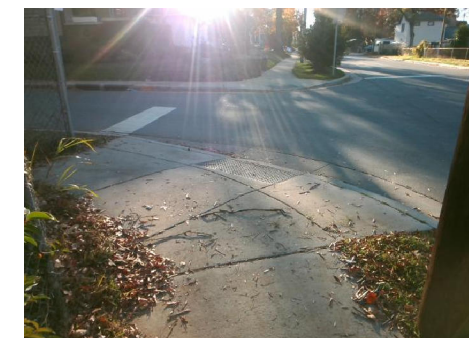
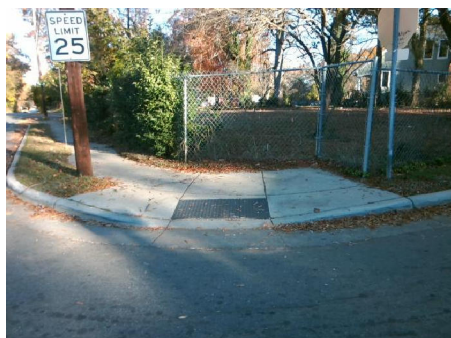
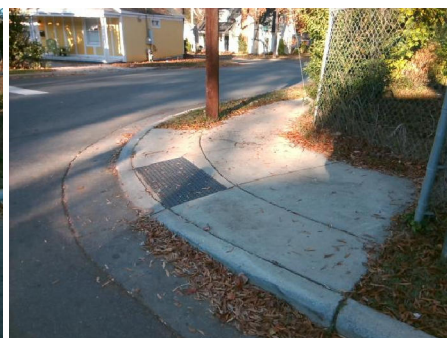
Not Found, R304.2.2

Compliance	Description	Data	Compliance	Description	Data
N/A	Ramp Length (in)	29.0	No	Ramp Slope (%)	11.0
Yes	Ramp Width (in)	48.0	Yes	Ramp XSlope (%)	1.9
N/A	Flare Type LT	N/A	N/A	Flare Type RT	N/A
N/A	Flare Slope LT (%)	N/A	N/A	Flare Slope RT (%)	N/A
N/A	Flare Traversable LT?	N/A	N/A	Flare Traversable RT?	N/A
N/A	Landing Length (in)	N/A	N/A	DWS Provided?	N/A
N/A	Landing Width (in)	N/A	N/A	DWS Contrast?	N/A
N/A	Landing Slope (%)	N/A	N/A	DWS Length (in)	N/A
N/A	Landing X Slope (%)	N/A	N/A	DWS Full Width?	N/A
N/A	Landing Curb? (Y/N)	N/A	N/A	DWS Offset (in)	N/A
N/A	Shared Landing?	N/A			
N/A	Gutter Ponding?	N/A	N/A	Gutter Slope (%)	N/A
N/A	Gutter Lip Ht (in)	N/A	N/A	Gutter X Slope (%)	N/A
N/A	Painted X Walk1?	No	N/A	Painted X Walk2?	N/A
	X Walk 1 Direction	To SE		X Walk 2 Direction	N/A
N/A	X Walk 1 Width (in)	N/A	N/A	X Walk 2 Width (in)	N/A
	X Walk 1 Slope (%)	3.0		X Walk 2 Slope (%)	N/A
	X Walk 1 X Slope (%)	2.5		X Walk 2 X Slope (%)	N/A

N/A	Ramp inside XWalk1?	N/A	N/A	Ramp inside XWalk2?	N/A
	Road Slope (%)	N/A	N/A	Clear Space?	N/A
	Road X Slope (%)	N/A	N/A	Clear Space to XWalk (in)	N/A
N/A	Any Obstructions?	N/A	N/A	Storm Grate/Utility Hazard?	N/A
	Obstruction Type			Storm Grate/Utility Type	
		N/A			N/A
			Yes	Surface Condition? (G/P)	Good

Possible Solutions:

Remove & Replace Entire Ramp.
