Access Compliance Report

Public Rights-of-Way

(Curb Ramps)

Intersection ID: 18381	Main Street: BATHURST_DR	Cross Street: WYALONG_DR	Location:	N
ADA ID: C857F03E6DCE	Ramp Type: Perp	Initial Pass/Fail: Fail	Overall Compliance: No	Severity Score: 12.5
Codes/Mitigation Info/Possible Solution		Field Measurements/Component Compliance

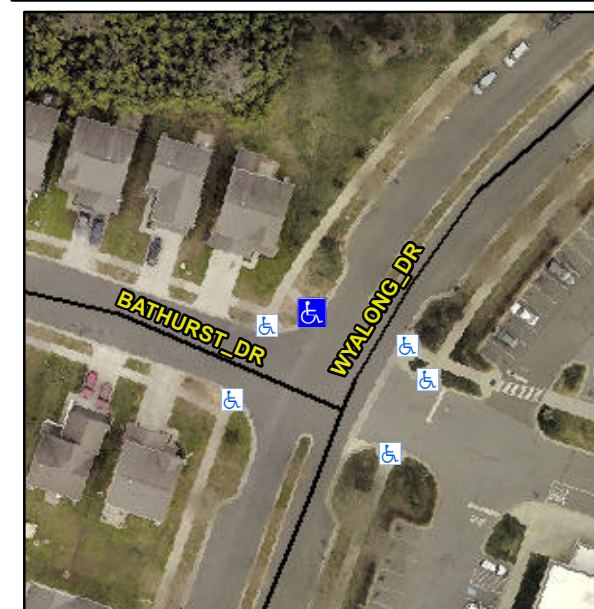
Compliance	Description	Data	Compliance	Description	Data
N/A	Ramp Length (in)	69.0	No	Ramp Slope (%)	8.5
Yes	Ramp Width (in)	71.0	Yes	Ramp XSlope (%)	1.3
N/A	Flare Type LT	N/A	N/A	Flare Type RT	N/A
N/A	Flare Slope LT (%)	N/A	N/A	Flare Slope RT (%)	N/A
N/A	Flare Traversable LT?	N/A	N/A	Flare Traversable RT?	N/A
N/A	Landing Length (in)	N/A	N/A	DWS Provided?	N/A
N/A	Landing Width (in)	N/A	N/A	DWS Contrast?	N/A
N/A	Landing Slope (%)	N/A	N/A	DWS Length (in)	N/A
N/A	Landing X Slope (%)	N/A	N/A	DWS Full Width?	N/A
N/A	Landing Curb? (Y/N)	N/A	N/A	DWS Offset (in)	N/A
N/A	Shared Landing?	N/A			
N/A	Gutter Ponding?	N/A	N/A	Gutter Slope (%)	N/A
N/A	Gutter Lip Ht (in)	N/A	N/A	Gutter X Slope (%)	N/A
N/A	Painted X Walk1?	No	N/A	Painted X Walk2?	N/A
	X Walk 1 Direction	To SE		X Walk 2 Direction	N/A
N/A	X Walk 1 Width (in)	N/A	N/A	X Walk 2 Width (in)	N/A
	X Walk 1 Slope (%)	3.2		X Walk 2 Slope (%)	N/A
	X Walk 1 X Slope (%)	1.1		X Walk 2 X Slope (%)	N/A

Possible Solutions:

Remove & Replace Entire Ramp.

R304.2.2
