Access Compliance Report Public Rights-of-Way (Curb Ramps)

Intersection ID: 42372 Main Street: COOPER'S RIDGE LN **Cross Street: RIDGE RD** Location: W

Overall Compliance: No ADA ID: C865B05F2E1D Ramp Type: PerpDiag Initial Pass/Fail: Fail **Severity Score:** 8.75

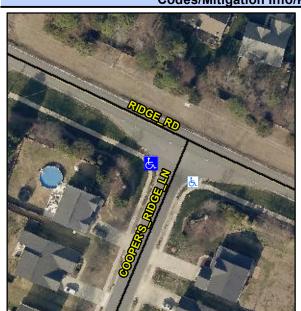
Compl	liance Description	Data	Comp	iance Description	Data
N/A	Ramp Length (in)	45.0	Yes	Ramp Slope (%)	7.3
No	Ramp Width (in)	43.0	Yes	Ramp XSlope (%)	1.6
N/A	Flare Type LT	N/A	N/A	Flare Type RT	N/A
N/A	Flare Slope LT (%)	N/A	N/A	Flare Slope RT (%)	N/A
N/A	Flare Traversable LT?	N/A	N/A	Flare Traversable RT?	N/A
N/A	Landing Length (in)	N/A	N/A	DWS Provided?	N/A
N/A	Landing Width (in)	N/A	N/A	DWS Contrast?	N/A
N/A	Landing Slope (%)	N/A	N/A	DWS Length (in)	N/A
N/A	Landing X Slope (%)	N/A	N/A	DWS Full Width?	N/A
N/A	Landing Curb? (Y/N)	N/A	N/A	DWS Offset (in)	N/A
N/A	Shared Landing?	N/A			
N/A	Gutter Ponding?	N/A	N/A	Gutter Slope (%)	N/A
N/A	Gutter Lip Ht (in)	N/A	N/A	Gutter X Slope (%)	N/A
N/A	Painted X Walk1?	No	N/A	Painted X Walk2?	No
	X Walk 1 Direction	To SE		X Walk 2 Direction	To NE
N/A	X Walk 1 Width (in)	N/A	N/A	X Walk 2 Width (in)	N/A
	X Walk 1 Slope (%)	4.1		X Walk 2 Slope (%)	6.4
	X Walk 1 X Slope (%)	6.9		X Walk 2 X Slope (%)	2.7

N/A	Ramp inside XWalk1?	N/A	N/A	Ramp inside XWalk2?	N/A
	Road Slope (%)	4.2	N/A	Clear Space?	N/A
	Road X Slope (%)	6.8	N/A	Clear Space to XWalk (in)	N/A
N/A	Any Obstructions?	N/A	N/A	Storm Grate/Utility Hazard?	N/A
	Obstruction Type		l	Storm Grate/Utility Type	
		N/A	l		N/A

Possible Solutions: Remove & Replace Curb Ramp With Two New Directional Ramps or Equivalent. Surveyor Notes: N/A PROW/ADA:

R304.5.1
