# Access Compliance Report

## Public Rights-of-Way

### (Curb Ramps)

Intersection ID: 44610	Main Street: FIG_LN	Cross Street: PINYON_PINE_LN	Location: NW
ADA ID: C86BF5476B84	Ramp Type: PerpDiag	Initial Pass/Fail: Fail	Overall Compliance: No
		Severity Score: 8.75

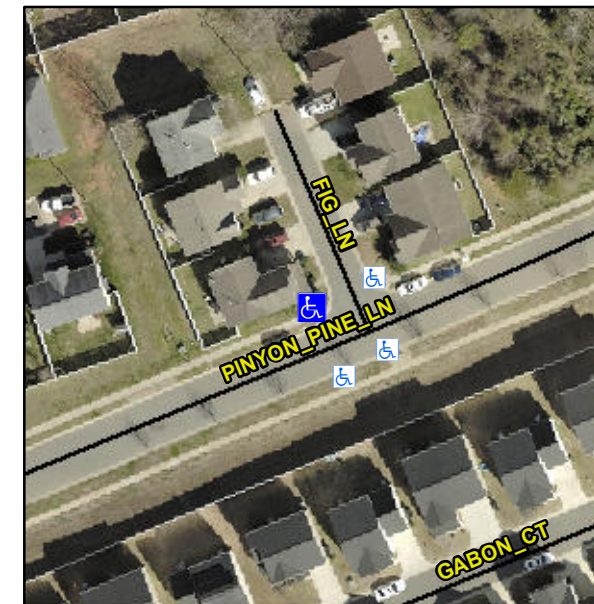
**Not Found, R304.5.1**

Compliance	Description	Data	Compliance	Description	Data
N/A	Ramp Length (in)	38.0	Yes	Ramp Slope (%)	5.5
No	Ramp Width (in)	47.0	Yes	Ramp XSlope (%)	1.1
N/A	Flare Type LT	N/A	N/A	Flare Type RT	N/A
N/A	Flare Slope LT (%)	N/A	N/A	Flare Slope RT (%)	N/A
N/A	Flare Traversable LT?	N/A	N/A	Flare Traversable RT?	N/A
N/A	Landing Length (in)	N/A	N/A	DWS Provided?	N/A
N/A	Landing Width (in)	N/A	N/A	DWS Contrast?	N/A
N/A	Landing Slope (%)	N/A	N/A	DWS Length (in)	N/A
N/A	Landing X Slope (%)	N/A	N/A	DWS Full Width?	N/A
N/A	Landing Curb? (Y/N)	N/A	N/A	DWS Offset (in)	N/A
N/A	Shared Landing?	N/A			
N/A	Gutter Ponding?	N/A	N/A	Gutter Slope (%)	N/A
N/A	Gutter Lip Ht (in)	N/A	N/A	Gutter X Slope (%)	N/A
N/A	Painted X Walk1?	No	N/A	Painted X Walk2?	No
	X Walk 1 Direction	To S		X Walk 2 Direction	To E
N/A	X Walk 1 Width (in)	N/A	N/A	X Walk 2 Width (in)	N/A
	X Walk 1 Slope (%)	3.5		X Walk 2 Slope (%)	1.7
	X Walk 1 X Slope (%)	2.5		X Walk 2 X Slope (%)	1.5

N/A	Ramp inside XWalk1?	N/A	N/A	Ramp inside XWalk2?	N/A
	Road Slope (%)	0.4	N/A	Clear Space?	N/A
	Road X Slope (%)	2.8	N/A	Clear Space to XWalk (in)	N/A
N/A	Any Obstructions?	N/A	N/A	Storm Grate/Utility Hazard?	N/A
	Obstruction Type			Storm Grate/Utility Type	
		N/A			N/A
			Yes	Surface Condition? (G/P)	Good

**Remove & Replace Curb Ramp With Two New Directional Ramps or Equivalent.**

Total Cost: \$ 3200.00
