# Access Compliance Report

## Public Rights-of-Way

### (Curb Ramps)

| Intersection ID: 52956 | Main Street: OLD_POST_RD | Cross Street: CONFERENCE_DR | Location: SE |

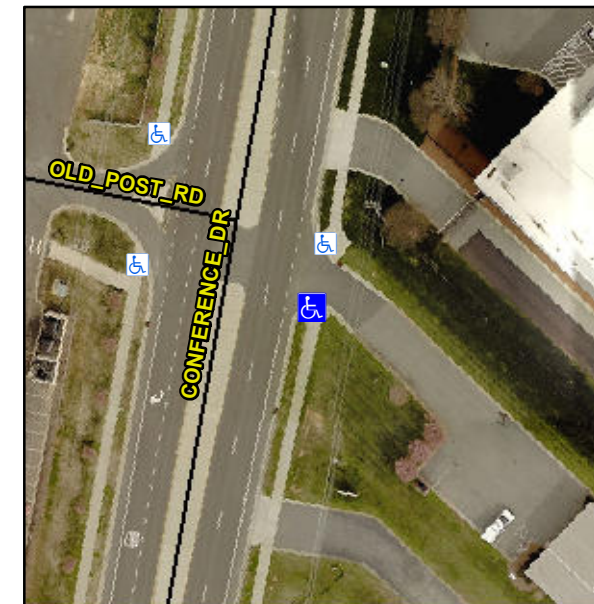
| ADA ID: C87588444086 | Ramp Type: Perp | Initial Pass/Fail: Fail | Overall Compliance: No |
| Severity Score: 12.5 | | | |

**Not Found, R304.5.3**

| Compliance | Description | Data | Compliance | Description | Data |
|---|---|---|---|---|---|
| Yes | Ramp Width (in) | 48.0 | No | Ramp XSlope (%) | 5.3 |

**Remove & Replace Entire Ramp.**

Total Cost: \$ 1850.00
