## **Access Compliance Report Public Rights-of-Way** (Curb Ramps)

Intersection ID: 10140 Main Street: E\_36TH\_ST Cross Street: N\_ALEXANDER\_ST Location: W **ADA ID: C8793A7F9CB8** Ramp Type: PerpDiag Initial Pass/Fail: Fail **Overall Compliance: No Severity Score:** 1.25

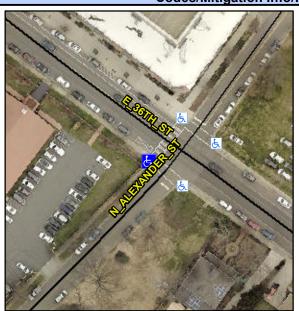
**NALEXANDER ST** Street 1 Name Stop Condition-Street 2 StopSign Street 2 Name E 36TH ST Stop Condition-Street 1 StopSign

| Field Measurements/Component Compliance | | | | | | |
|---|---|---|---|---|---|---|
| | Yes | Ramp Width (in) | 48.0 | No | Ramp XSlope (%) | 2.3 |

Possible Solutions: Remove & Replace Curb Ramp With **Two New Directional Ramps or** Equivalent. Surveyor Notes: N/A PROW/ADA: Not Found, R304.5.3
