Access Compliance Report

Public Rights-of-Way

(Curb Ramps)

| Intersection ID: 50938 | Main Street: BLAIREBETH_ST | Cross Street: CANMORE_ST | Location: SE |

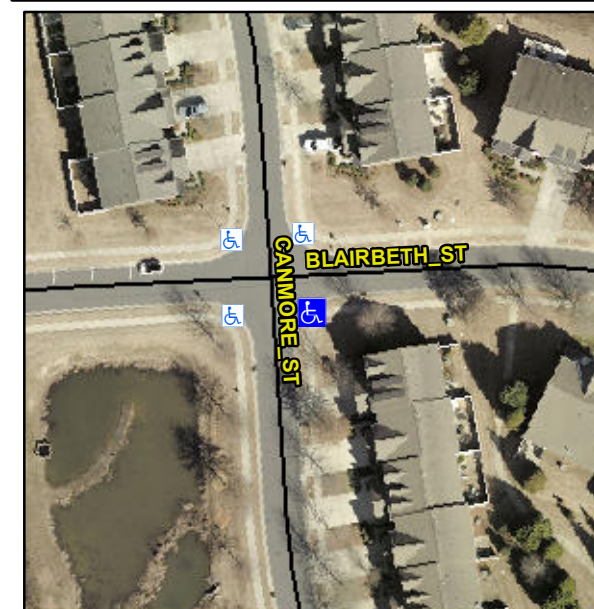
| ADA ID: C88B53D329ED | Ramp Type: PerpDiag | Initial Pass/Fail: Fail | Overall Compliance: No |
| Codes/Mitigation Info/Possible Solution | | | Severity Score: 10 |

Not Found, R304.5.1, R304.5.3

| Compliance | Description | Data | Compliance | Description | Data |
|---|---|---|---|---|---|
| N/A | Ramp Length (in) | 48.0 | Yes | Ramp Slope (%) | 5.8 |
| No | Ramp Width (in) | 44.0 | No | Ramp XSlope (%) | 4.9 |

Remove & Replace Curb Ramp With Two New Directional Ramps or Equivalent.

Total Cost: \$ 3200.00
