Access Compliance Report

Public Rights-of-Way

(Curb Ramps)

Intersection ID: 43657	Main Street: TAYLOR RIDGE LN	Cross Street: SWANN BRANCH DR	Location: SE
ADA ID: C88BA052F4B3	Ramp Type: Perp	Initial Pass/Fail: Fail	Overall Compliance: No
Severity Score: 10			
Codes/Mitigation Info/Possible Solution		Field Measurements/Component Compliance

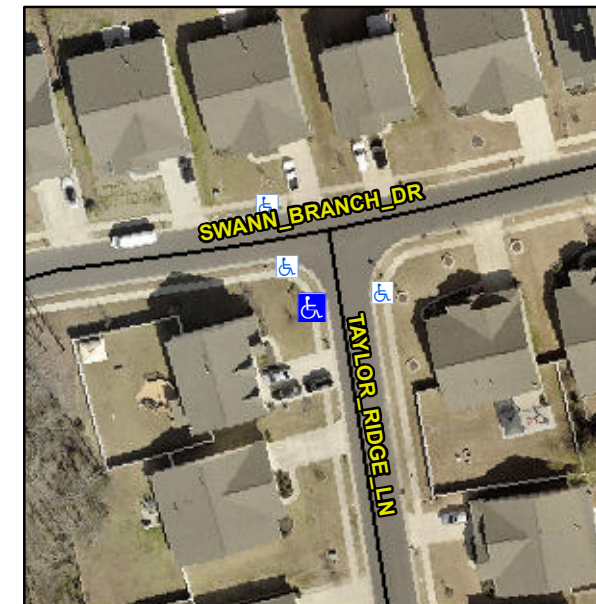
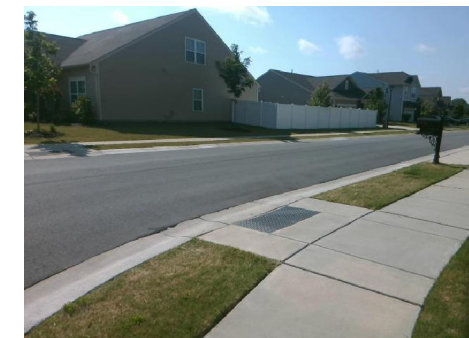
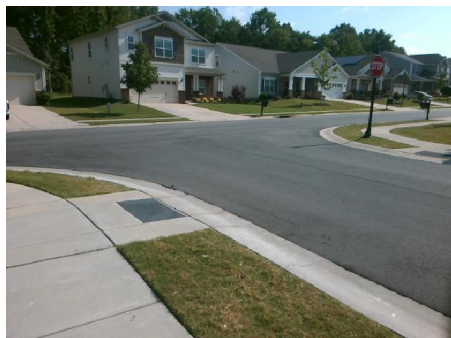
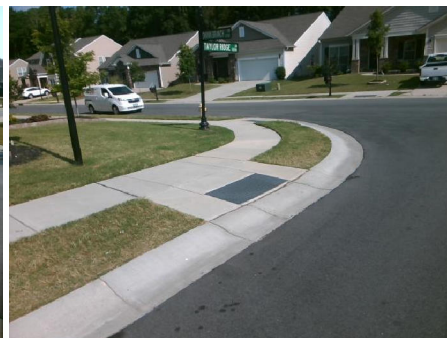
Not Found, R304.5.1, R304.5.3

Compliance	Description	Data	Compliance	Description	Data
N/A	Ramp Length (in)	48.0	Yes	Ramp Slope (%)	5.8
No	Ramp Width (in)	47.0	No	Ramp XSlope (%)	3.7
N/A	Flare Type LT	N/A	N/A	Flare Type RT	N/A
N/A	Flare Slope LT (%)	N/A	N/A	Flare Slope RT (%)	N/A
N/A	Flare Traversable LT?	N/A	N/A	Flare Traversable RT?	N/A
N/A	Landing Length (in)	N/A	N/A	DWS Provided?	N/A
N/A	Landing Width (in)	N/A	N/A	DWS Contrast?	N/A
N/A	Landing Slope (%)	N/A	N/A	DWS Length (in)	N/A
N/A	Landing X Slope (%)	N/A	N/A	DWS Full Width?	N/A
N/A	Landing Curb? (Y/N)	N/A	N/A	DWS Offset (in)	N/A
N/A	Shared Landing?	N/A			
N/A	Gutter Ponding?	N/A	N/A	Gutter Slope (%)	N/A
N/A	Gutter Lip Ht (in)	N/A	N/A	Gutter X Slope (%)	N/A
N/A	Painted X Walk1?	No	N/A	Painted X Walk2?	N/A
	X Walk 1 Direction	To W		X Walk 2 Direction	N/A
N/A	X Walk 1 Width (in)	N/A	N/A	X Walk 2 Width (in)	N/A
	X Walk 1 Slope (%)	3.8		X Walk 2 Slope (%)	N/A
	X Walk 1 X Slope (%)	2.3		X Walk 2 X Slope (%)	N/A

N/A	Ramp inside XWalk1?	N/A	N/A	Ramp inside XWalk2?	N/A
	Road Slope (%)	N/A	N/A	Clear Space?	N/A
	Road X Slope (%)	N/A	N/A	Clear Space to XWalk (in)	N/A
N/A	Any Obstructions?	N/A	N/A	Storm Grate/Utility Hazard?	N/A
	Obstruction Type			Storm Grate/Utility Type	
		N/A			N/A
		Yes		Surface Condition? (G/P)	Good

Remove & Replace Entire Ramp.
