Access Compliance Report

Public Rights-of-Way

(Curb Ramps)

Intersection ID: 10041519	Main Street: WEYMOUTH_LN	Cross Street: N/A	Location: W
ADA ID: C88BE43AA784	Ramp Type: Perp	Initial Pass/Fail: Fail	Overall Compliance: No
Codes/Mitigation Info/Possible Solution		Field Measurements/Component Compliance	
Severity Score: 13.75

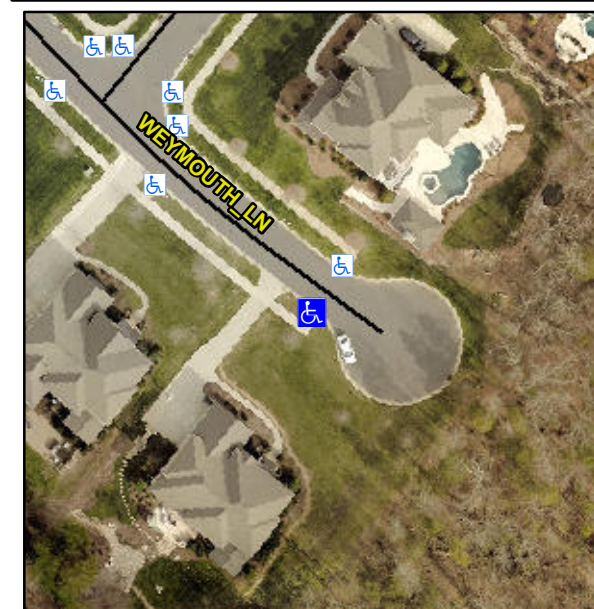
Not Found, R304.2.2, R304.5.3

Compliance	Description	Data	Compliance	Description	Data
N/A	Ramp Length (in)	83.0	No	Ramp Slope (%)	9.1
Yes	Ramp Width (in)	48.0	No	Ramp XSlope (%)	2.3
N/A	Flare Type LT	N/A	N/A	Flare Type RT	N/A
N/A	Flare Slope LT (%)	N/A	N/A	Flare Slope RT (%)	N/A
N/A	Flare Traversable LT?	N/A	N/A	Flare Traversable RT?	N/A
N/A	Landing Length (in)	N/A	N/A	DWS Provided?	N/A
N/A	Landing Width (in)	N/A	N/A	DWS Contrast?	N/A
N/A	Landing Slope (%)	N/A	N/A	DWS Length (in)	N/A
N/A	Landing X Slope (%)	N/A	N/A	DWS Full Width?	N/A
N/A	Landing Curb? (Y/N)	N/A	N/A	DWS Offset (in)	N/A
N/A	Shared Landing?	N/A			
N/A	Gutter Ponding?	N/A	N/A	Gutter Slope (%)	N/A
N/A	Gutter Lip Ht (in)	N/A	N/A	Gutter X Slope (%)	N/A
N/A	Painted X Walk1?	No	N/A	Painted X Walk2?	N/A
	X Walk 1 Direction	To NE		X Walk 2 Direction	N/A
N/A	X Walk 1 Width (in)	N/A	N/A	X Walk 2 Width (in)	N/A
	X Walk 1 Slope (%)	2.5		X Walk 2 Slope (%)	N/A
	X Walk 1 X Slope (%)	2.0		X Walk 2 X Slope (%)	N/A

N/A	Ramp inside XWalk1?	N/A	N/A	Ramp inside XWalk2?	N/A
	Road Slope (%)	N/A	N/A	Clear Space?	N/A
	Road X Slope (%)	N/A	N/A	Clear Space to XWalk (in)	N/A
N/A	Any Obstructions?	N/A	N/A	Storm Grate/Utility Hazard?	N/A
	Obstruction Type			Storm Grate/Utility Type	
		N/A			N/A
			Yes	Surface Condition? (G/P)	Good

Possible Solutions:

Remove & Replace Entire Ramp.
