Access Compliance Report

Public Rights-of-Way

(Curb Ramps)

Intersection ID: 30169	Main Street: BUTTONBUSH_CT	Cross Street: SLATER_RIDGE_DR	Location: SE
ADA ID: C88EF8E465F8	Ramp Type: BlendTrans2	Initial Pass/Fail: Fail	Overall Compliance: No
Severity Score: 12.5			
Codes/Mitigation Info/Possible Solution		Field Measurements/Component Compliance

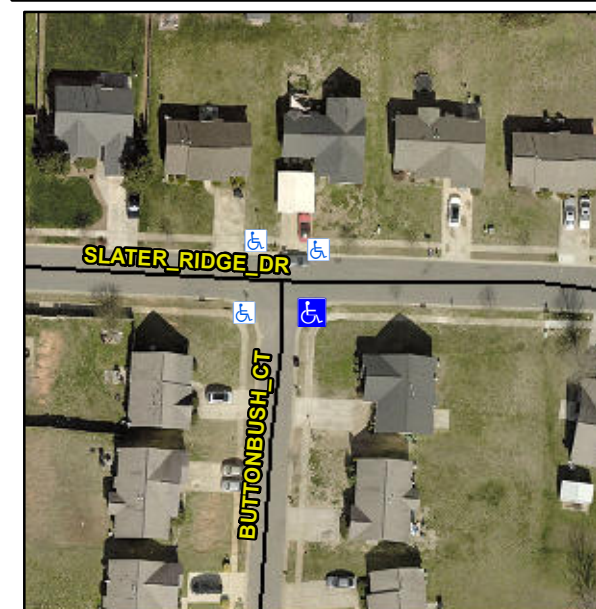
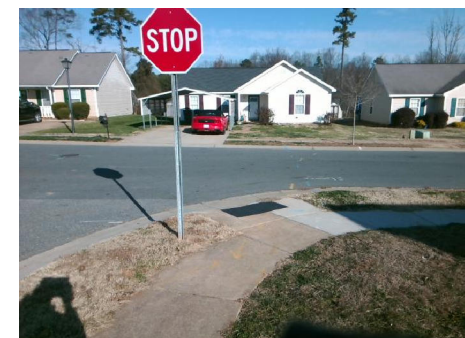
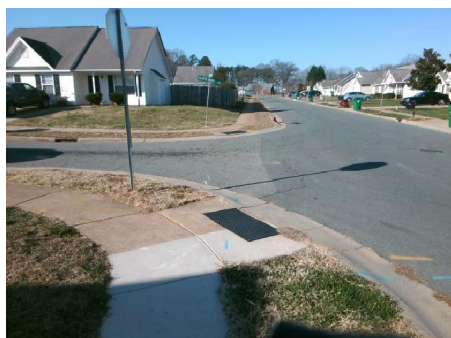
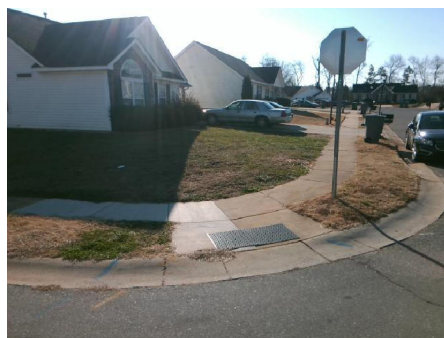
Not Found, R304.5.3

Compliance	Description	Data	Compliance	Description	Data
N/A	Ramp Length (in)	93.5	Yes	BlendTrans Slope (%)	3.3
Yes	Ramp Width (in)	48.0	No	BlendTrans XSlope (%)	5.2
N/A	Flare Type LT	N/A	N/A	Flare Type RT	N/A
N/A	Flare Slope LT (%)	N/A	N/A	Flare Slope RT (%)	N/A
N/A	Flare Traversable LT?	N/A	N/A	Flare Traversable RT?	N/A
N/A	Landing Length (in)	N/A	N/A	DWS Provided?	N/A
N/A	Landing Width (in)	N/A	N/A	DWS Contrast?	N/A
N/A	Landing Slope (%)	N/A	N/A	DWS Length (in)	N/A
N/A	Landing X Slope (%)	N/A	N/A	DWS Full Width?	N/A
N/A	Landing Curb? (Y/N)	N/A	N/A	DWS Offset (in)	N/A
N/A	Shared Landing?	N/A			
N/A	Gutter Ponding?	N/A	N/A	Gutter Slope (%)	N/A
N/A	Gutter Lip Ht (in)	N/A	N/A	Gutter X Slope (%)	N/A
N/A	Painted X Walk1?	No	N/A	Painted X Walk2?	No
	X Walk 1 Direction	To W		X Walk 2 Direction	To N
	X Walk 1 Width (in)	N/A		X Walk 2 Width (in)	N/A
	X Walk 1 Slope (%)	0.4		X Walk 2 Slope (%)	2.2
	X Walk 1 X Slope (%)	2.1		X Walk 2 X Slope (%)	1.7

N/A	Ramp inside XWalk1?	N/A	N/A	Ramp inside XWalk2?	N/A
	Road Slope (%)	0.7		Clear Space?	N/A
	Road X Slope (%)	5.4	N/A	Clear Space to XWalk (in)	N/A
N/A	Any Obstructions?	N/A	N/A	Storm Grate/Utility Hazard?	N/A
	Obstruction Type			Storm Grate/Utility Type	
		N/A			N/A
			Yes	Surface Condition? (G/P)	Good
			No	Curb Slope (%)	7.9

Remove & Replace Curb Ramp With Two New Directional Ramps or Equivalent.
