Access Compliance Report

Public Rights-of-Way

(Curb Ramps)

Intersection ID: 9059	Main Street: GLENWOOD_DR	Cross Street: S_I85_EXIT_35_RA	Location: S
ADA ID: C89CADC8E56A	Ramp Type: PerpDiag	Initial Pass/Fail: Fail	Overall Compliance: No
		Severity Score: 30

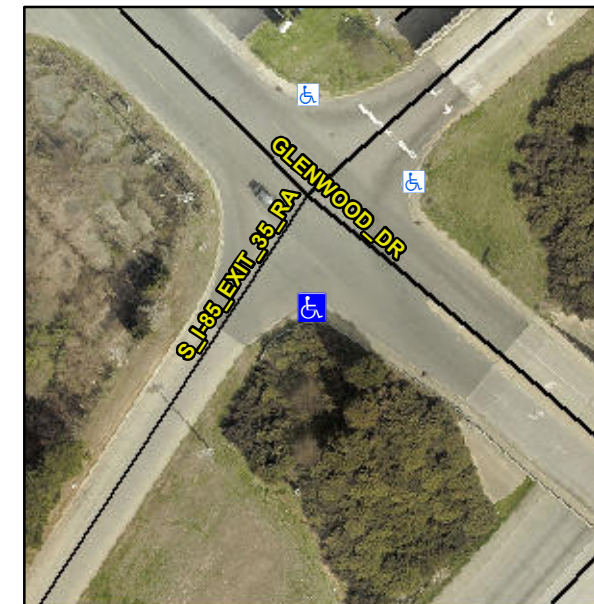
Not Found, R304.5.1, R304.2.2

Compliance	Description	Data	Compliance	Description	Data
N/A	Ramp Length (in)	59.0	No	Ramp Slope (%)	10.4
No	Ramp Width (in)	35.0	Yes	Ramp XSlope (%)	0.6
N/A	Flare Type LT	N/A	N/A	Flare Type RT	N/A
N/A	Flare Slope LT (%)	N/A	N/A	Flare Slope RT (%)	N/A
N/A	Flare Traversable LT?	N/A	N/A	Flare Traversable RT?	N/A
N/A	Landing Length (in)	N/A	N/A	DWS Provided?	N/A
N/A	Landing Width (in)	N/A	N/A	DWS Contrast?	N/A
N/A	Landing Slope (%)	N/A	N/A	DWS Length (in)	N/A
N/A	Landing X Slope (%)	N/A	N/A	DWS Full Width?	N/A
N/A	Landing Curb? (Y/N)	N/A	N/A	DWS Offset (in)	N/A
N/A	Shared Landing?	N/A			
N/A	Gutter Ponding?	N/A	N/A	Gutter Slope (%)	N/A
N/A	Gutter Lip Ht (in)	N/A	N/A	Gutter X Slope (%)	N/A
N/A	Painted X Walk1?	No	N/A	Painted X Walk2?	No
	X Walk 1 Direction	To NE		X Walk 2 Direction	To NW
N/A	X Walk 1 Width (in)	N/A	N/A	X Walk 2 Width (in)	N/A
	X Walk 1 Slope (%)	1.2		X Walk 2 Slope (%)	1.8
	X Walk 1 X Slope (%)	2.4		X Walk 2 X Slope (%)	0.9

N/A	Ramp inside XWalk1?	N/A	N/A	Ramp inside XWalk2?	N/A
	Road Slope (%)	1.1	N/A	Clear Space?	N/A
	Road X Slope (%)	2.2	N/A	Clear Space to XWalk (in)	N/A
N/A	Any Obstructions?	N/A	N/A	Storm Grate/Utility Hazard?	N/A
	Obstruction Type			Storm Grate/Utility Type	
		N/A			N/A
			Yes	Surface Condition? (G/P)	Good

Remove & Replace Curb Ramp With Two New Directional Ramps or Equivalent.
