# Access Compliance Report

## Public Rights-of-Way

### (Curb Ramps)

Intersection ID: 31839	Main Street: RUGGED_STONE_WY	Cross Street: SILVER_FALLS_WY	Location: NE
ADA ID: C8A134C62FE0	Ramp Type: Perp	Initial Pass/Fail: Fail	Overall Compliance: No
Severity Score: 13.75			
Codes/Mitigation Info/Possible Solution		Field Measurements/Component Compliance

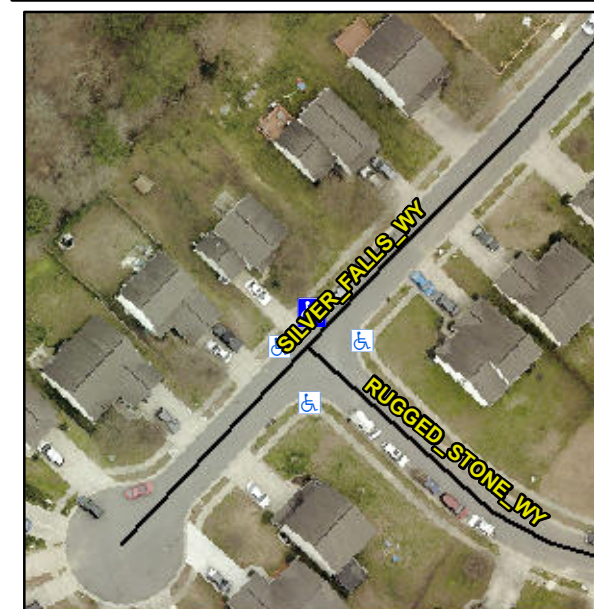
**Not Found, R304.2.2, R304.5.3**

Compliance	Description	Data	Compliance	Description	Data
N/A	Ramp Length (in)	46.0	No	Ramp Slope (%)	8.5
Yes	Ramp Width (in)	48.0	No	Ramp XSlope (%)	2.5
N/A	Flare Type LT	N/A	N/A	Flare Type RT	N/A
N/A	Flare Slope LT (%)	N/A	N/A	Flare Slope RT (%)	N/A
N/A	Flare Traversable LT?	N/A	N/A	Flare Traversable RT?	N/A
N/A	Landing Length (in)	N/A	N/A	DWS Provided?	N/A
N/A	Landing Width (in)	N/A	N/A	DWS Contrast?	N/A
N/A	Landing Slope (%)	N/A	N/A	DWS Length (in)	N/A
N/A	Landing X Slope (%)	N/A	N/A	DWS Full Width?	N/A
N/A	Landing Curb? (Y/N)	N/A	N/A	DWS Offset (in)	N/A
N/A	Shared Landing?	N/A			
N/A	Gutter Ponding?	N/A	N/A	Gutter Slope (%)	N/A
N/A	Gutter Lip Ht (in)	N/A	N/A	Gutter X Slope (%)	N/A
N/A	Painted X Walk1?	No	N/A	Painted X Walk2?	N/A
	X Walk 1 Direction	To SE		X Walk 2 Direction	N/A
N/A	X Walk 1 Width (in)	N/A	N/A	X Walk 2 Width (in)	N/A
	X Walk 1 Slope (%)	0.2		X Walk 2 Slope (%)	N/A
	X Walk 1 X Slope (%)	1.0		X Walk 2 X Slope (%)	N/A

N/A	Ramp inside XWalk1?	N/A	N/A	Ramp inside XWalk2?	N/A
	Road Slope (%)	N/A	N/A	Clear Space?	N/A
	Road X Slope (%)	N/A	N/A	Clear Space to XWalk (in)	N/A
N/A	Any Obstructions?	N/A	N/A	Storm Grate/Utility Hazard?	N/A
	Obstruction Type			Storm Grate/Utility Type	
		N/A			N/A
			Yes	Surface Condition? (G/P)	Good

**Remove & Replace Entire Ramp.**

Total Cost: \$ 1850.00
